Construction Progress Photo Report
August 18, 2011

Hemet High Modernization & Expansion

FACILITES & PLANNING DEPARTMENT

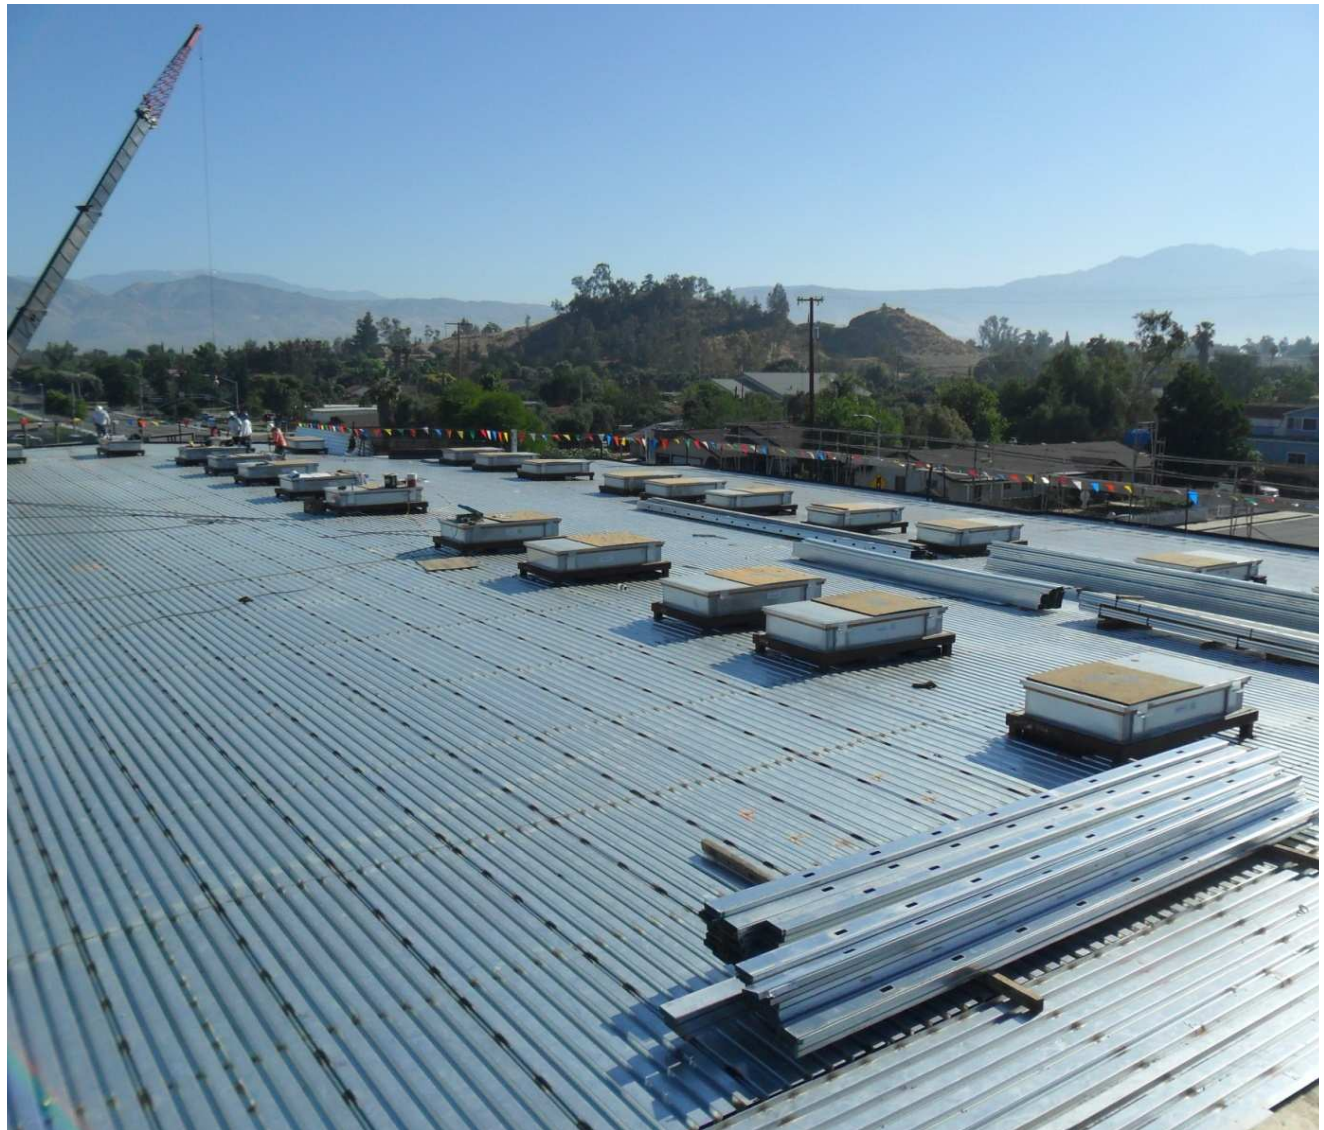
Classroom Building "C"

June 23rd, 2011: The roof deck has been completed and the HVAC curbs have been installed.

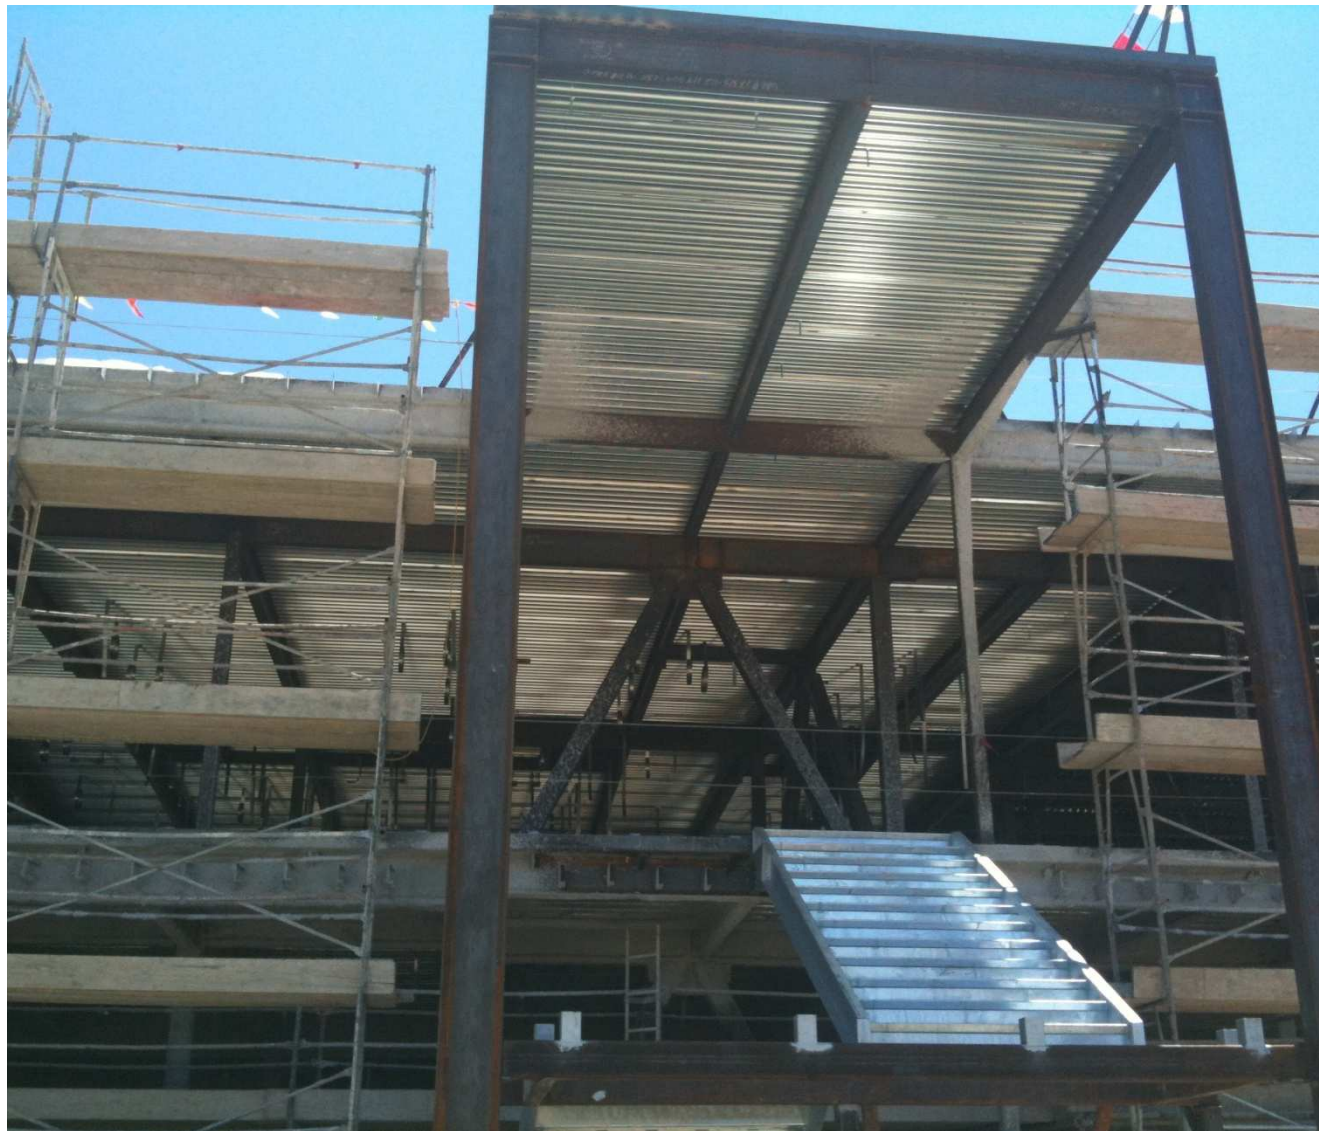
Classroom Building "C"

June 29th, 2011: The staircase at the west side of the building has been set into position. Scaffolding has also been erected for the exterior wall framing that is progressing from the east side of the building.

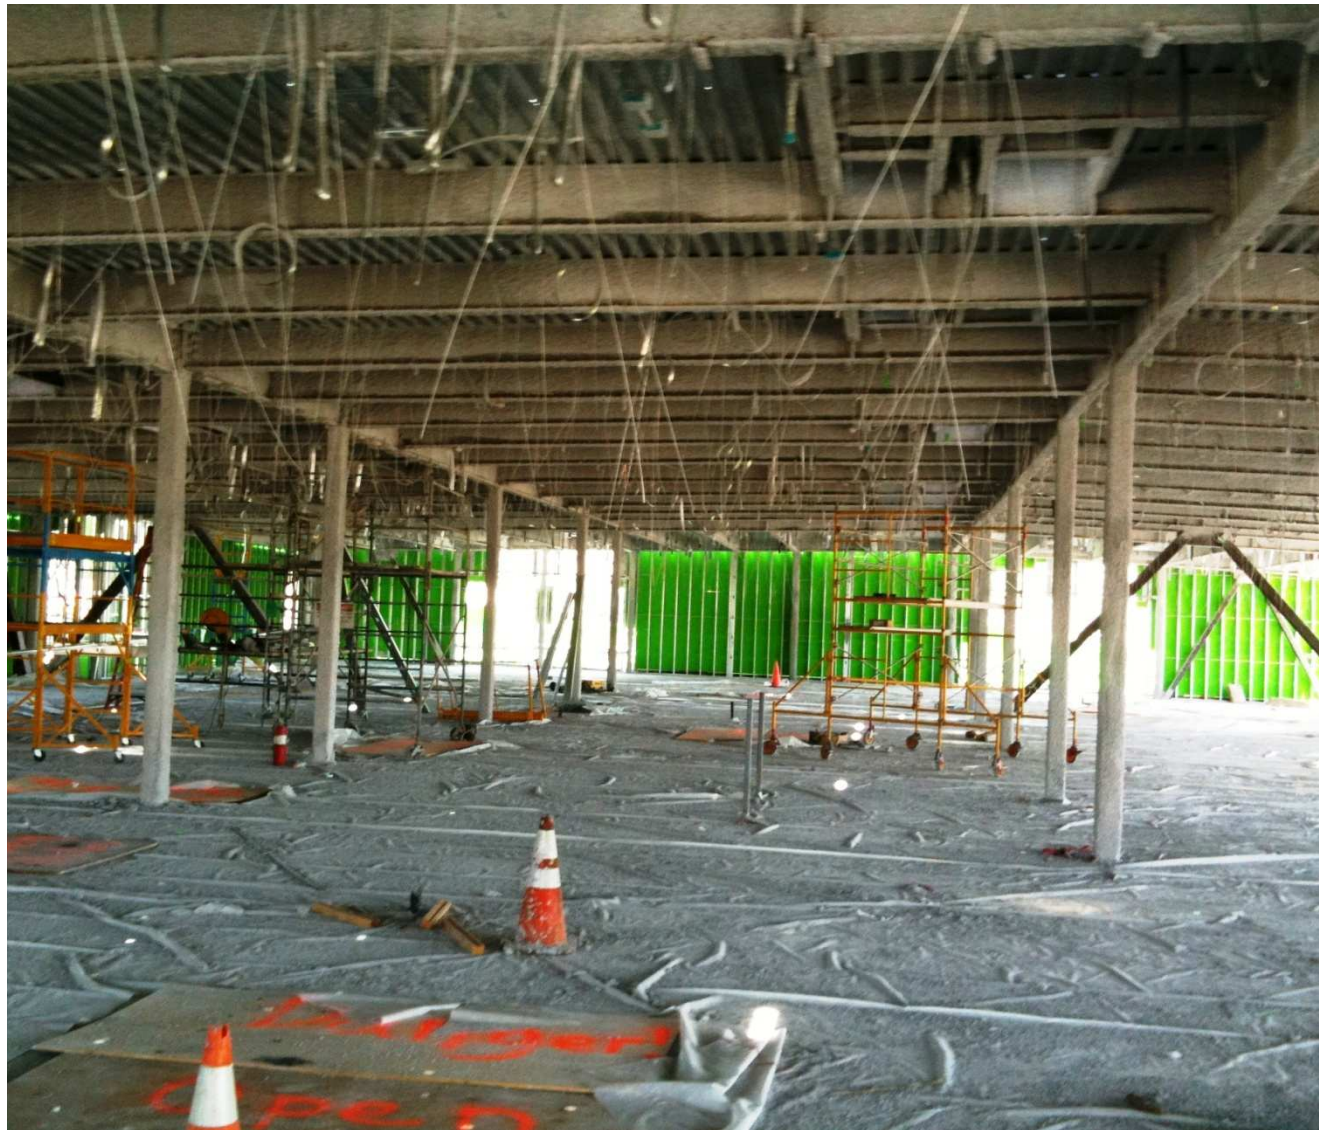
Classroom Building "C"

July 21st, 2011: Mechanical, electrical, plumbing, fire sprinkler, ceiling grid and data hangers have been installed.

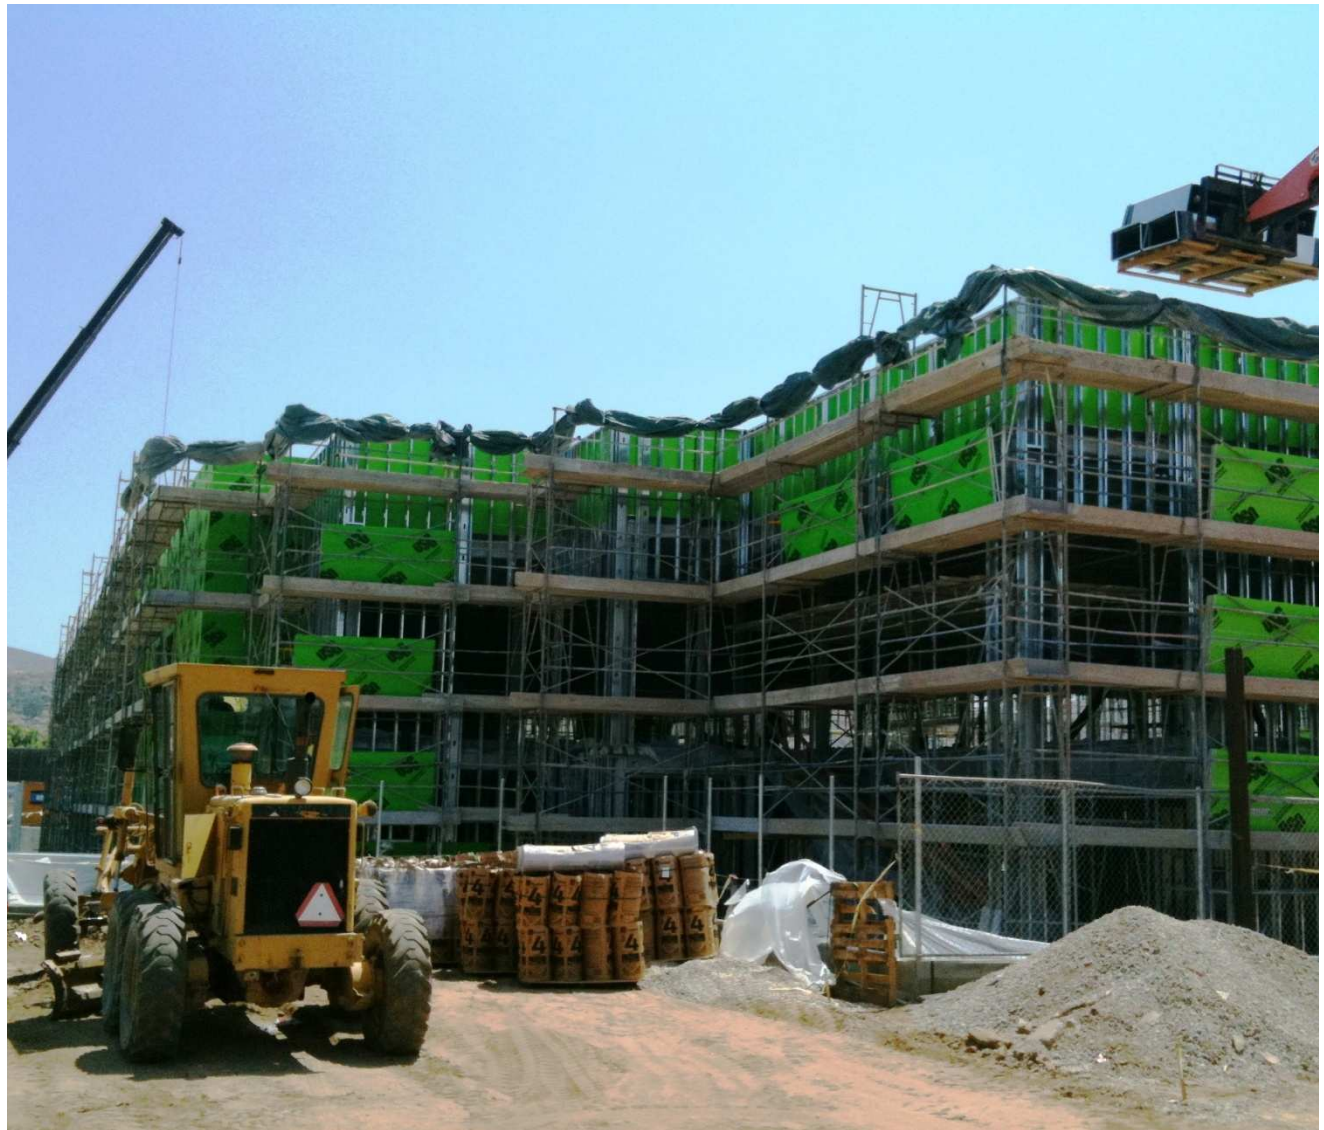
Classroom Building "C"

July 27th, 2011: Exterior sheathing has been completed on the south and east sides of the building and is wrapping around the north end of the building.

Roofing material is being loaded onto the roof along with the HVAC plenums.

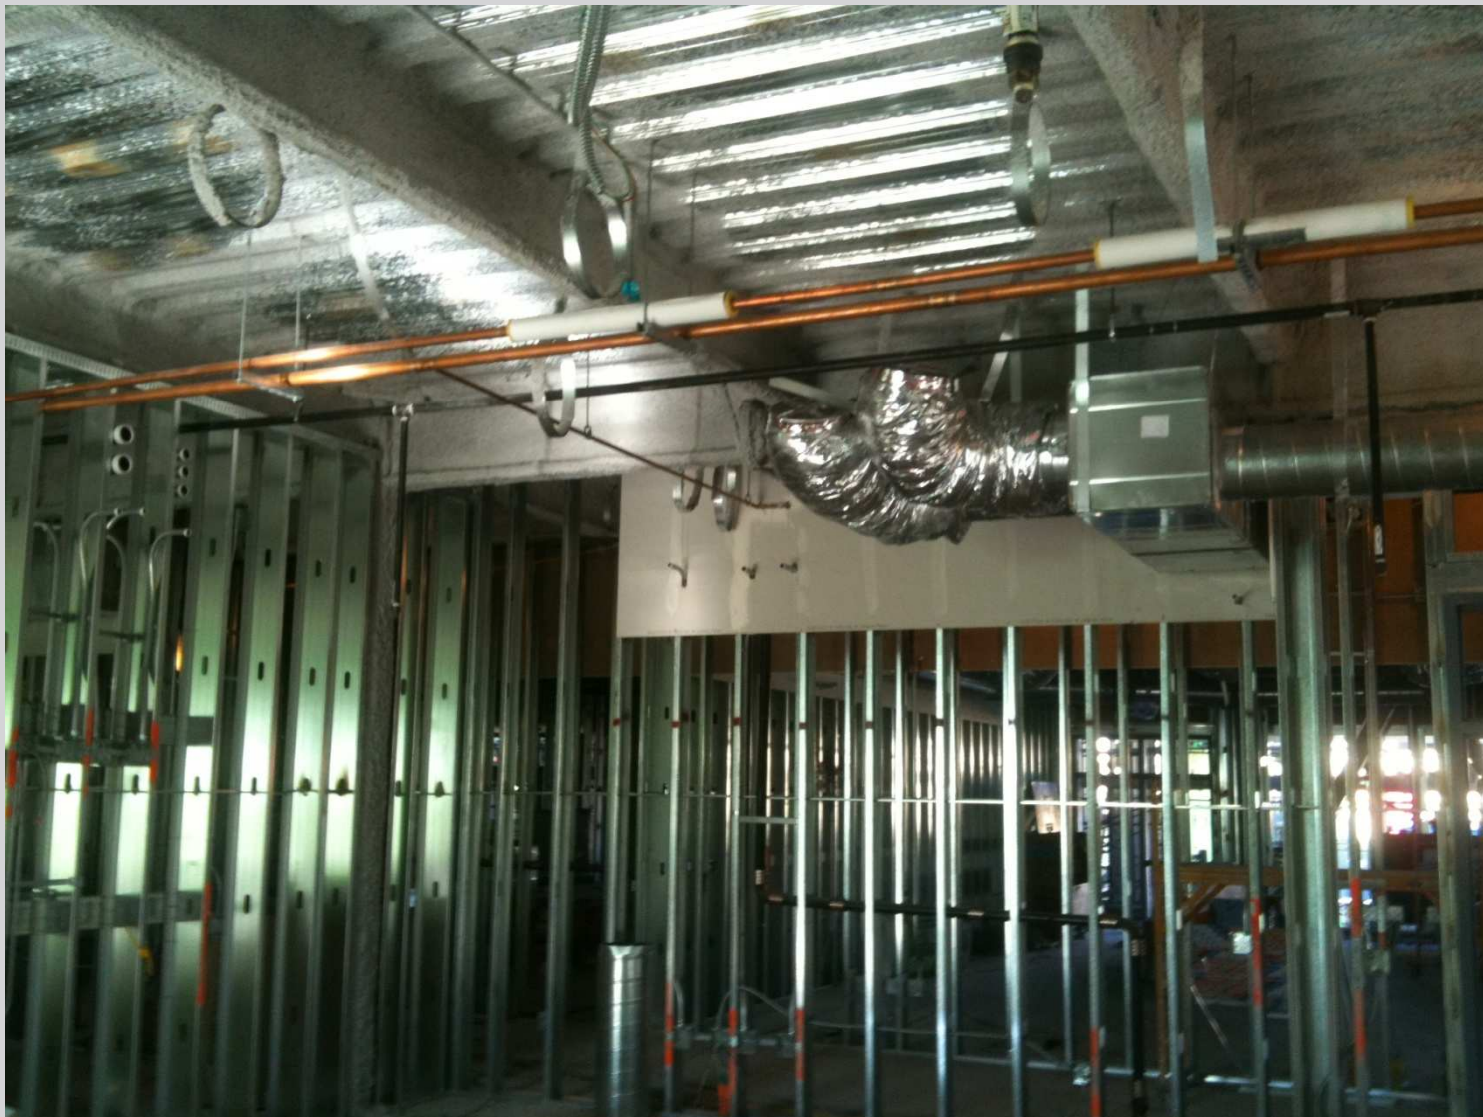
Building "C" -8/3/11: Ductwork installation is in progress.

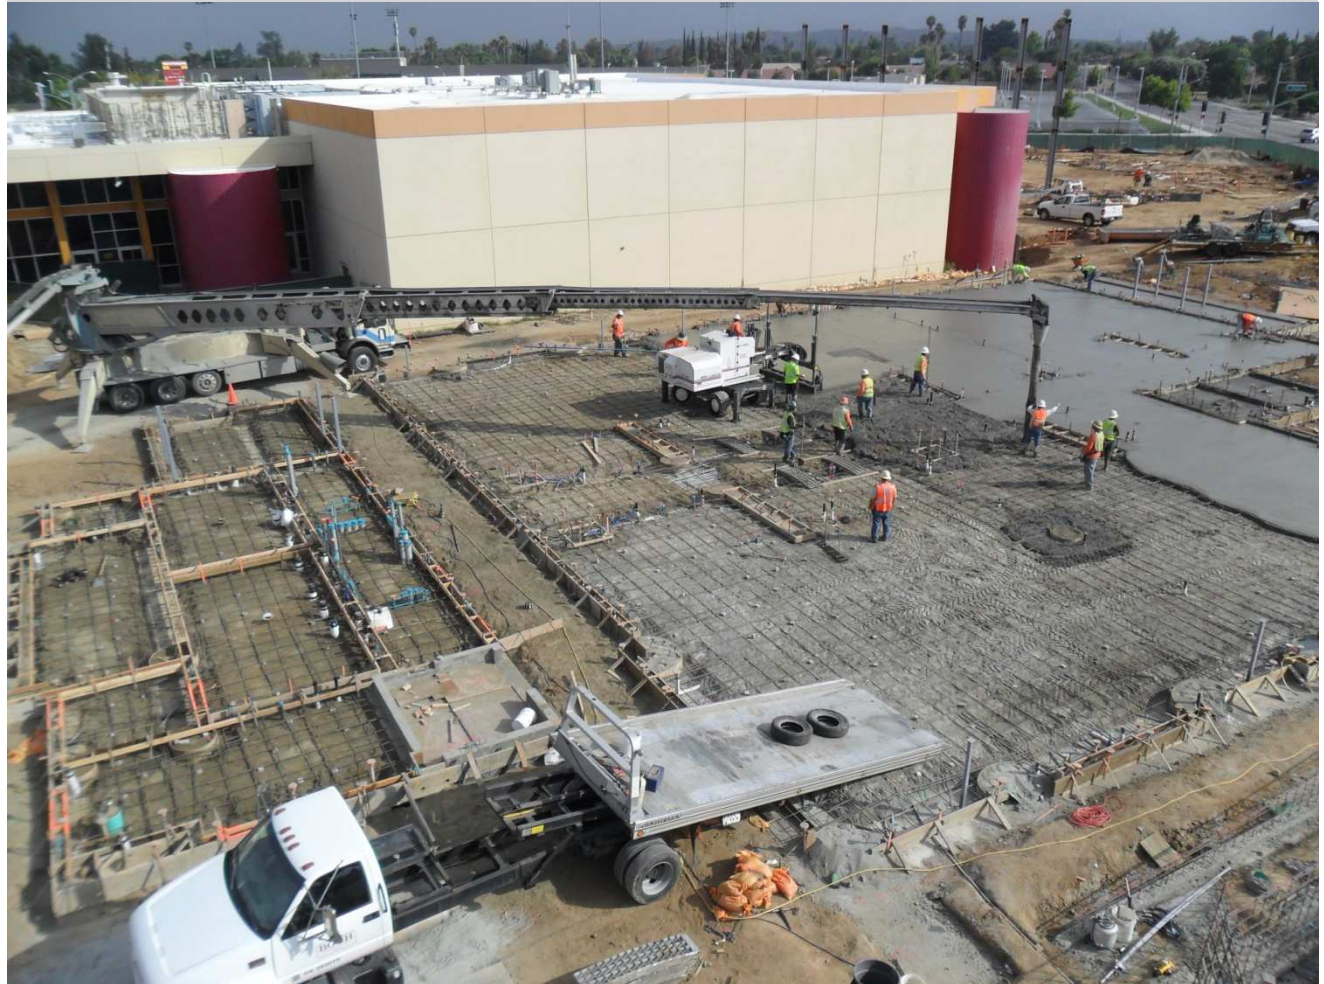
Science Classroom "B"

June 9th, 2011: The slab on grade pour in progress.

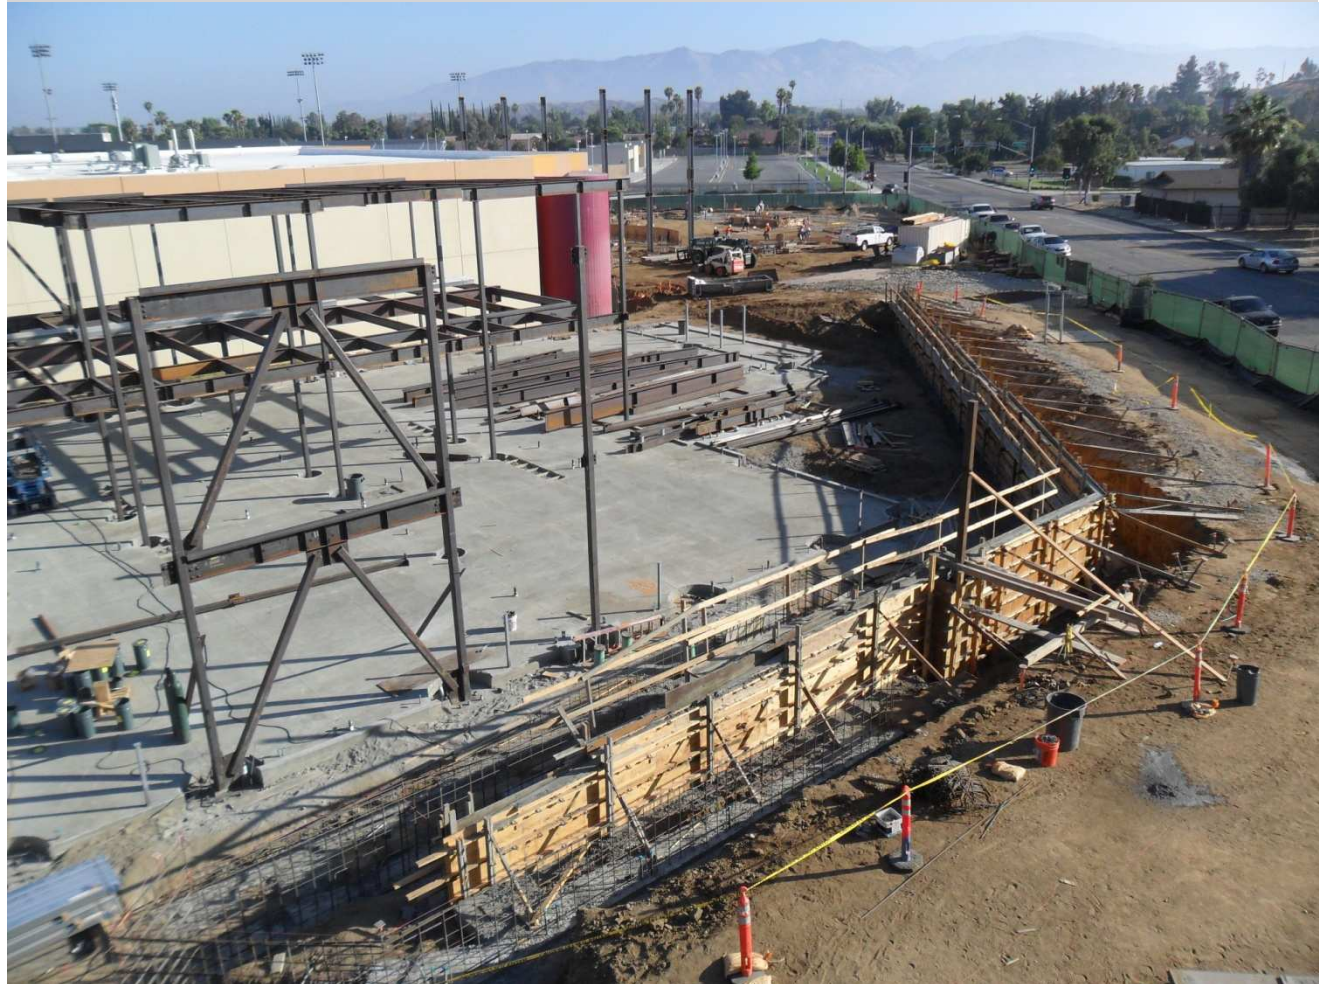
Science Building "B"

June 23rd, 2011: Steel erection in progress. The site wall has been formed and is ready to be poured.

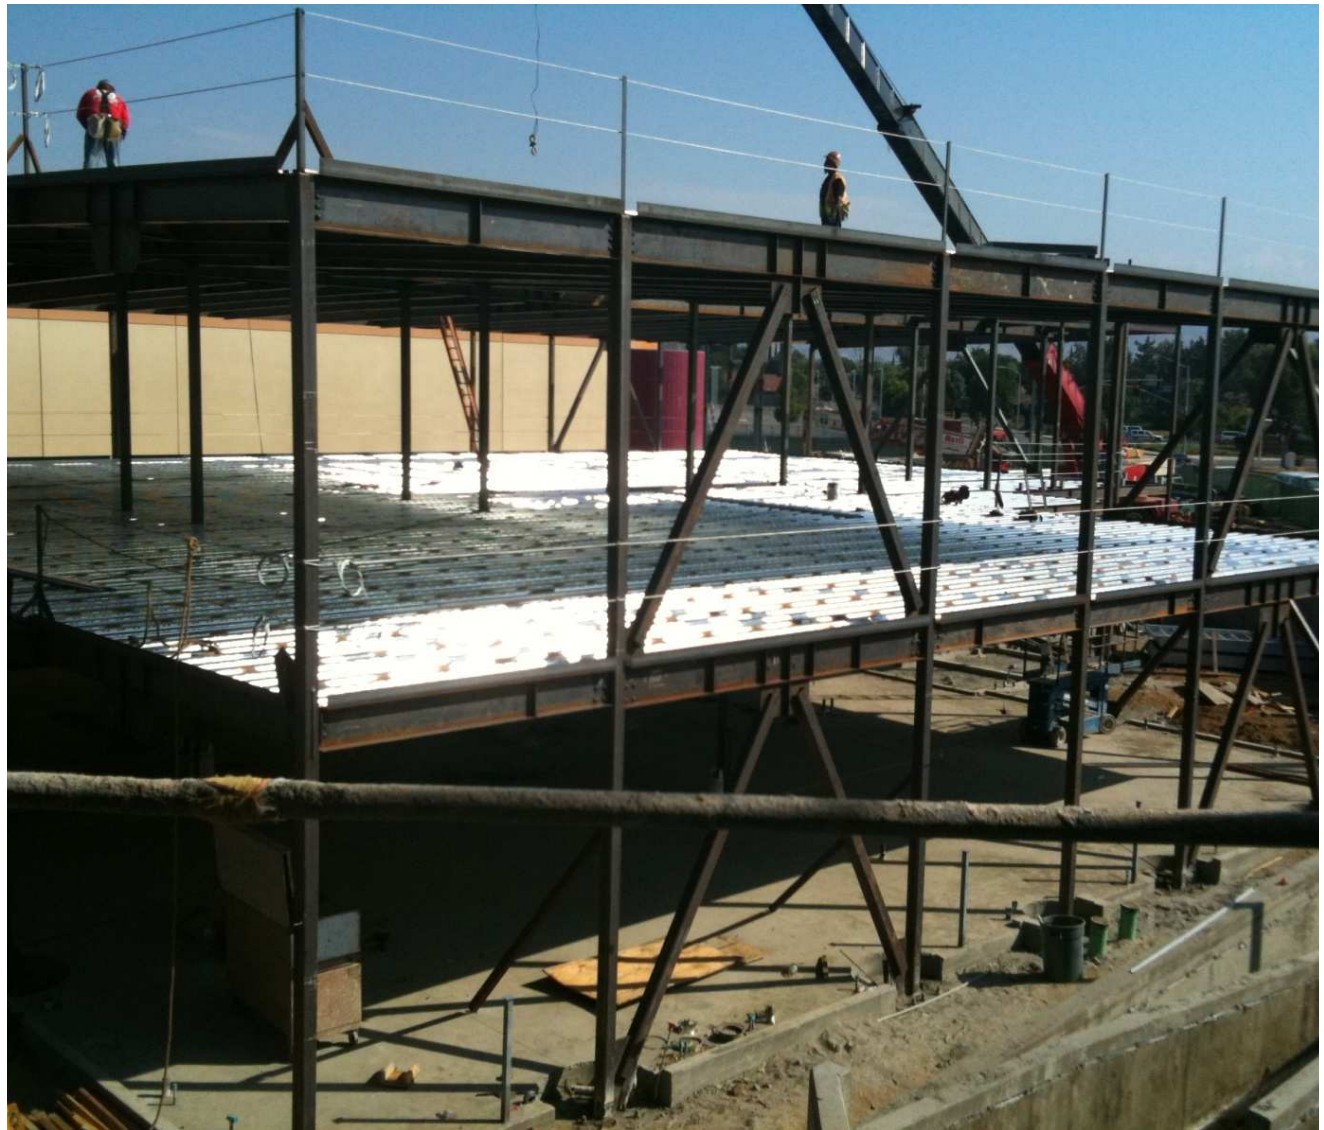
Classroom Building "B"

July 7th: 2nd floor deck has been spread out.

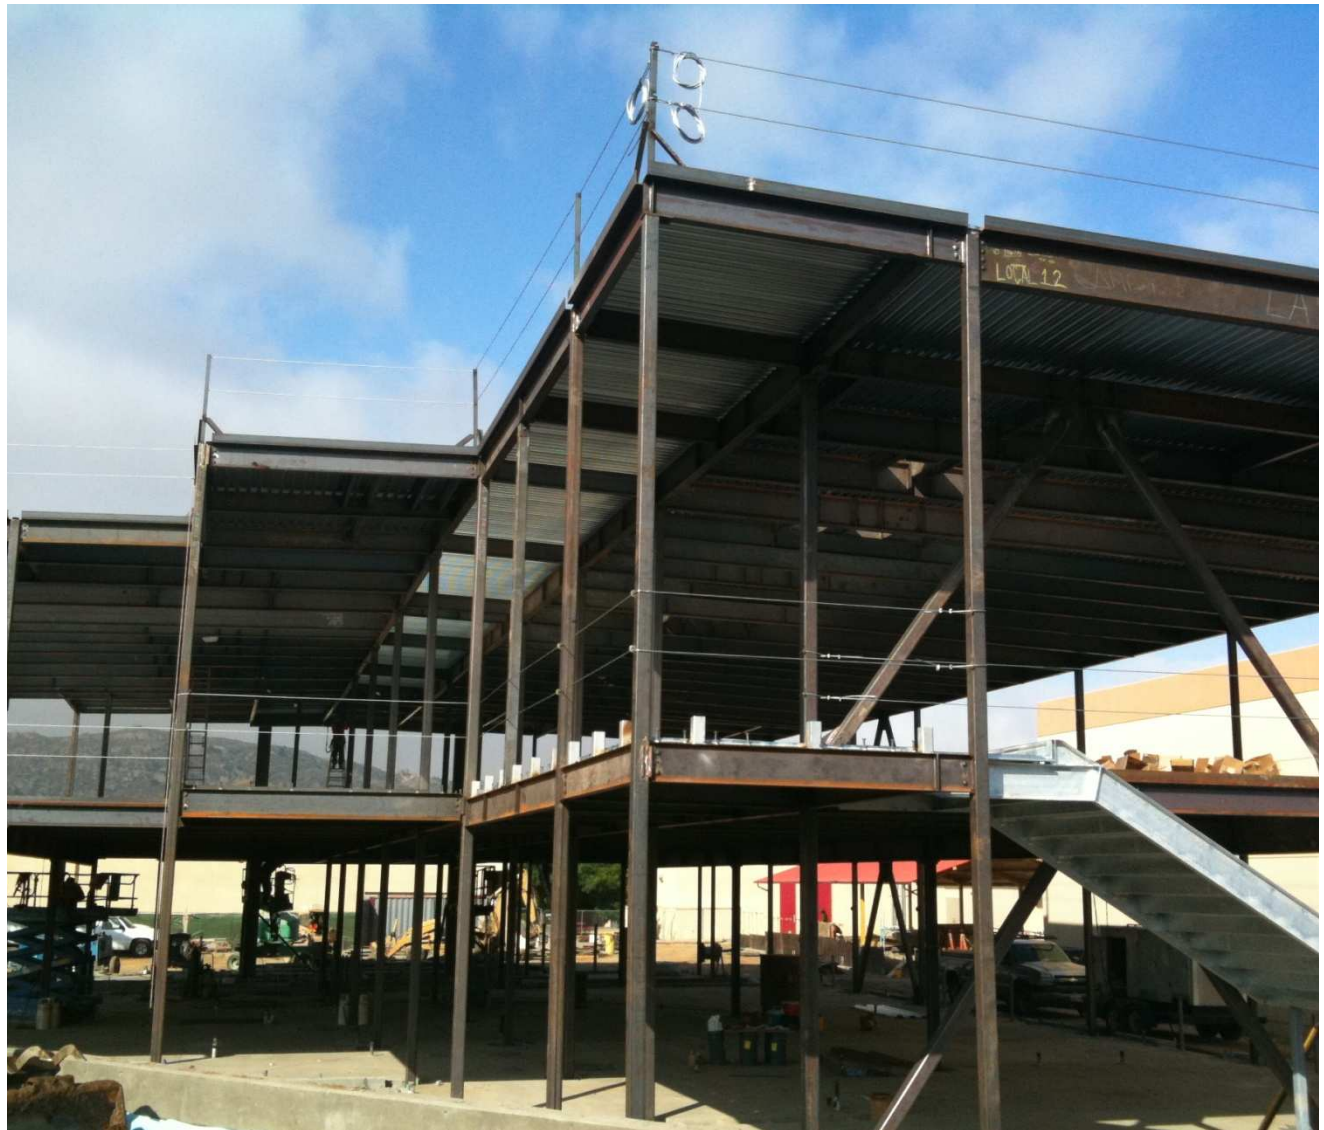
Classroom Building "B"

July 14th, 2011: Major structural steel erection has been completed. Stair cases are in the process of being secured and the safety railing system has been installed.

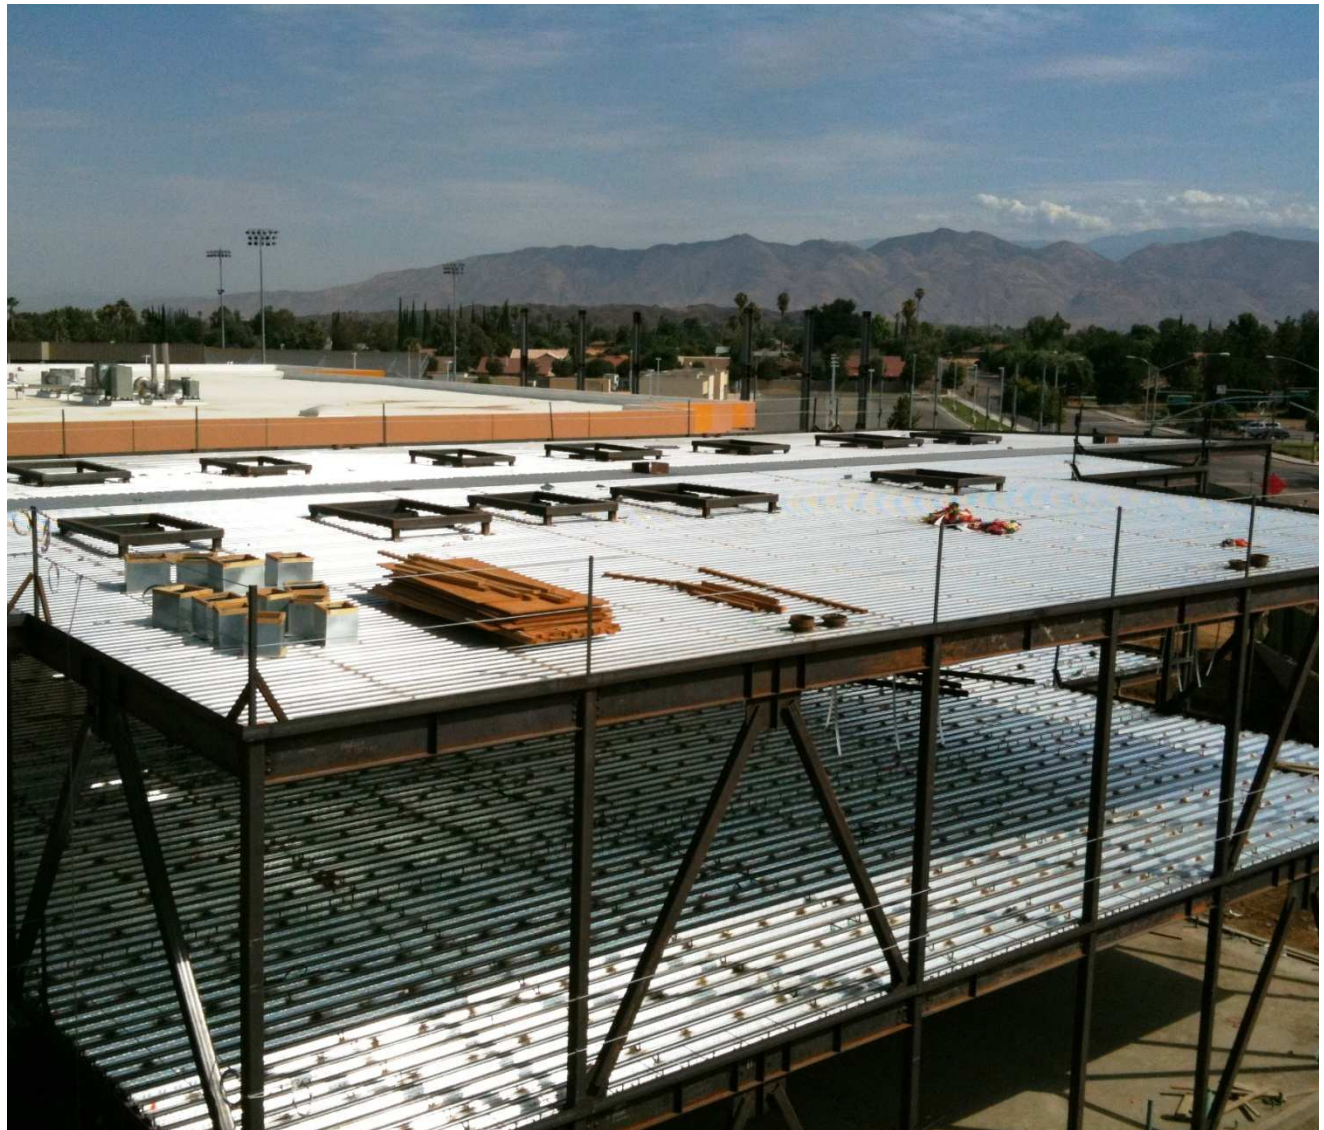
Science Building "B"

July 27th, 2011: The HVAC Mechanical platforms have been erected and roof drains have been installed.

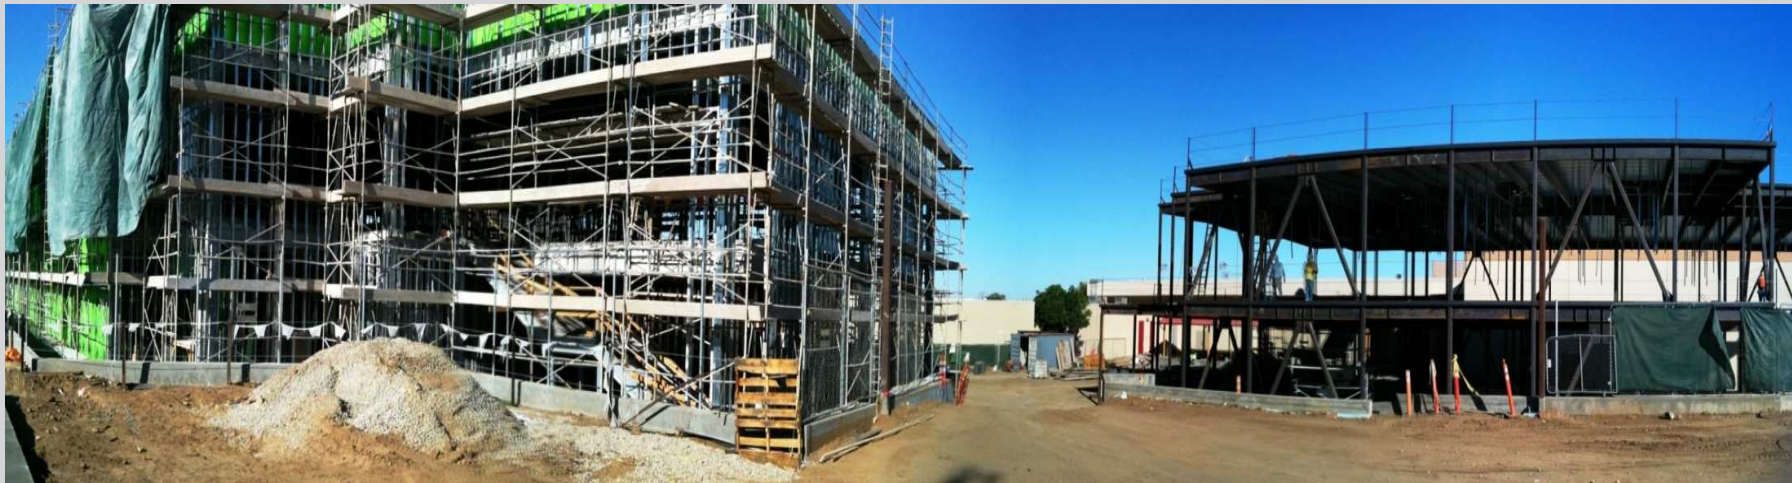
Classroom Buildings "B" & "C"

- July 21st: This is a side by side look of both buildings. A colonnade entryway will be constructed between the two buildings.

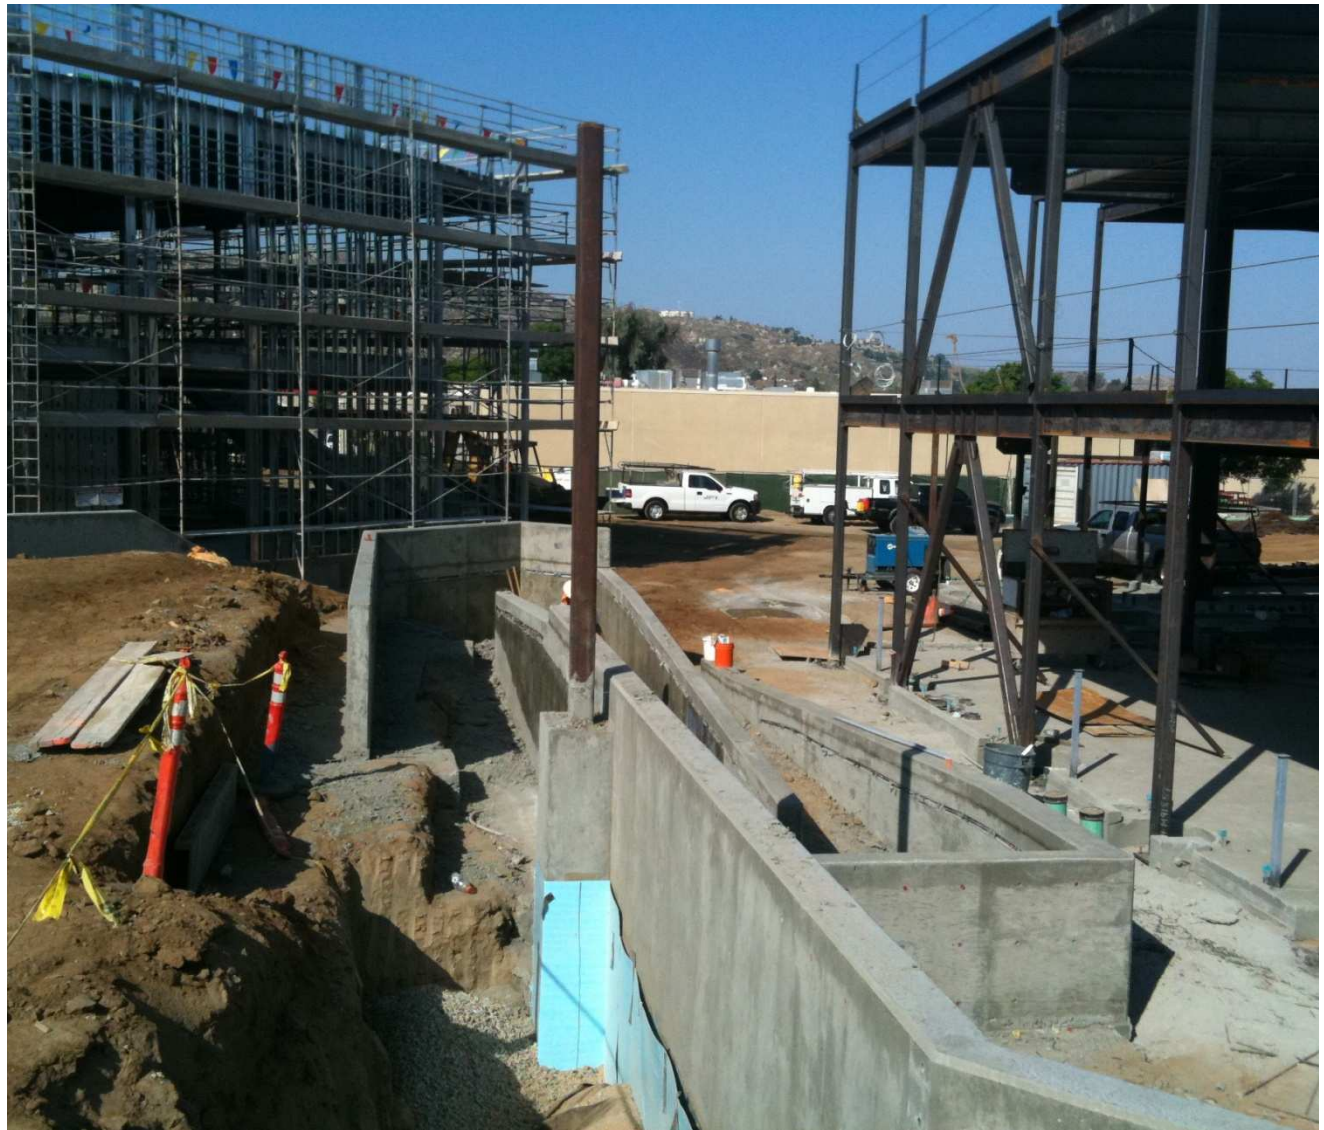
Switchback Ramp

July 7th, 2011: The switchback ramp walls have been constructed. A colonnade structure will close off the campus from the street. A column for that structure is shown adjacent to the ramp.

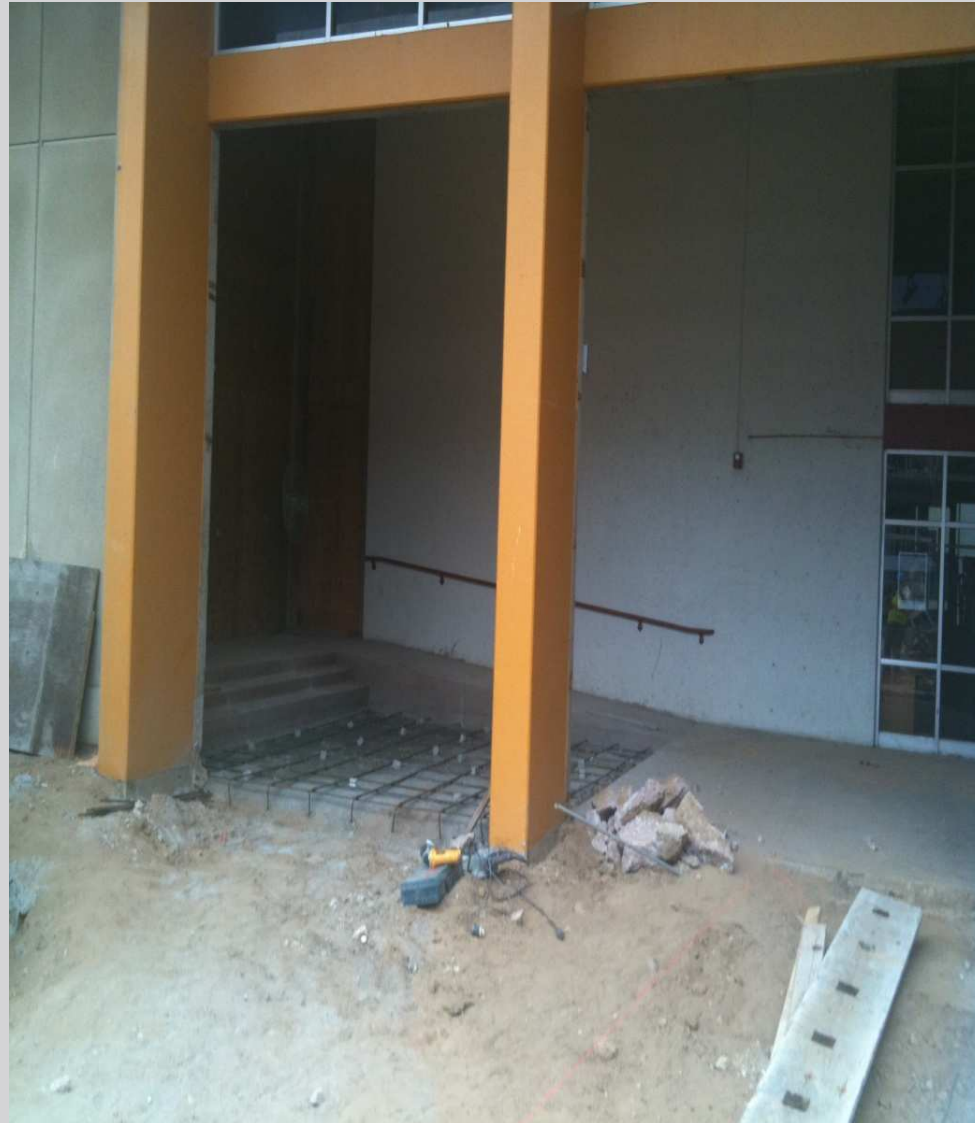
Summer Modernization

July 14th, 2011: The existing storefront entry has been removed and the new interior steps and ramp leading up to the commons area have been installed. A new storefront entry will be constructed here.

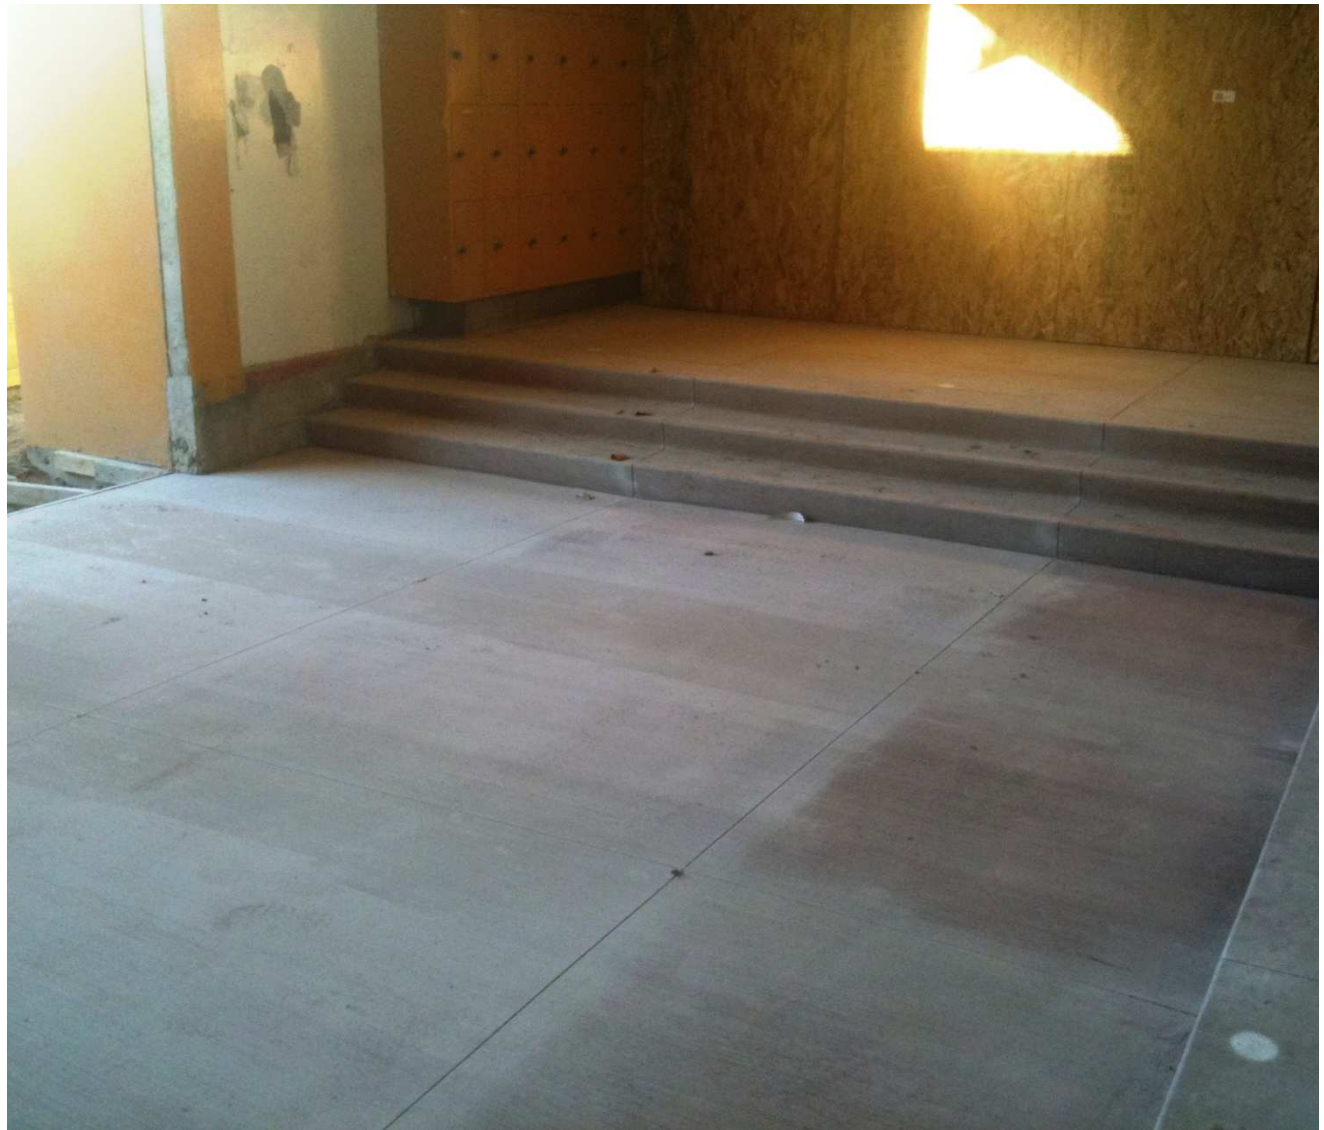
Summer Modernization

July 21st, 2011: All of the new concrete has been poured behind the library. New handrail will be installed at the stairs and adjacent ramp.

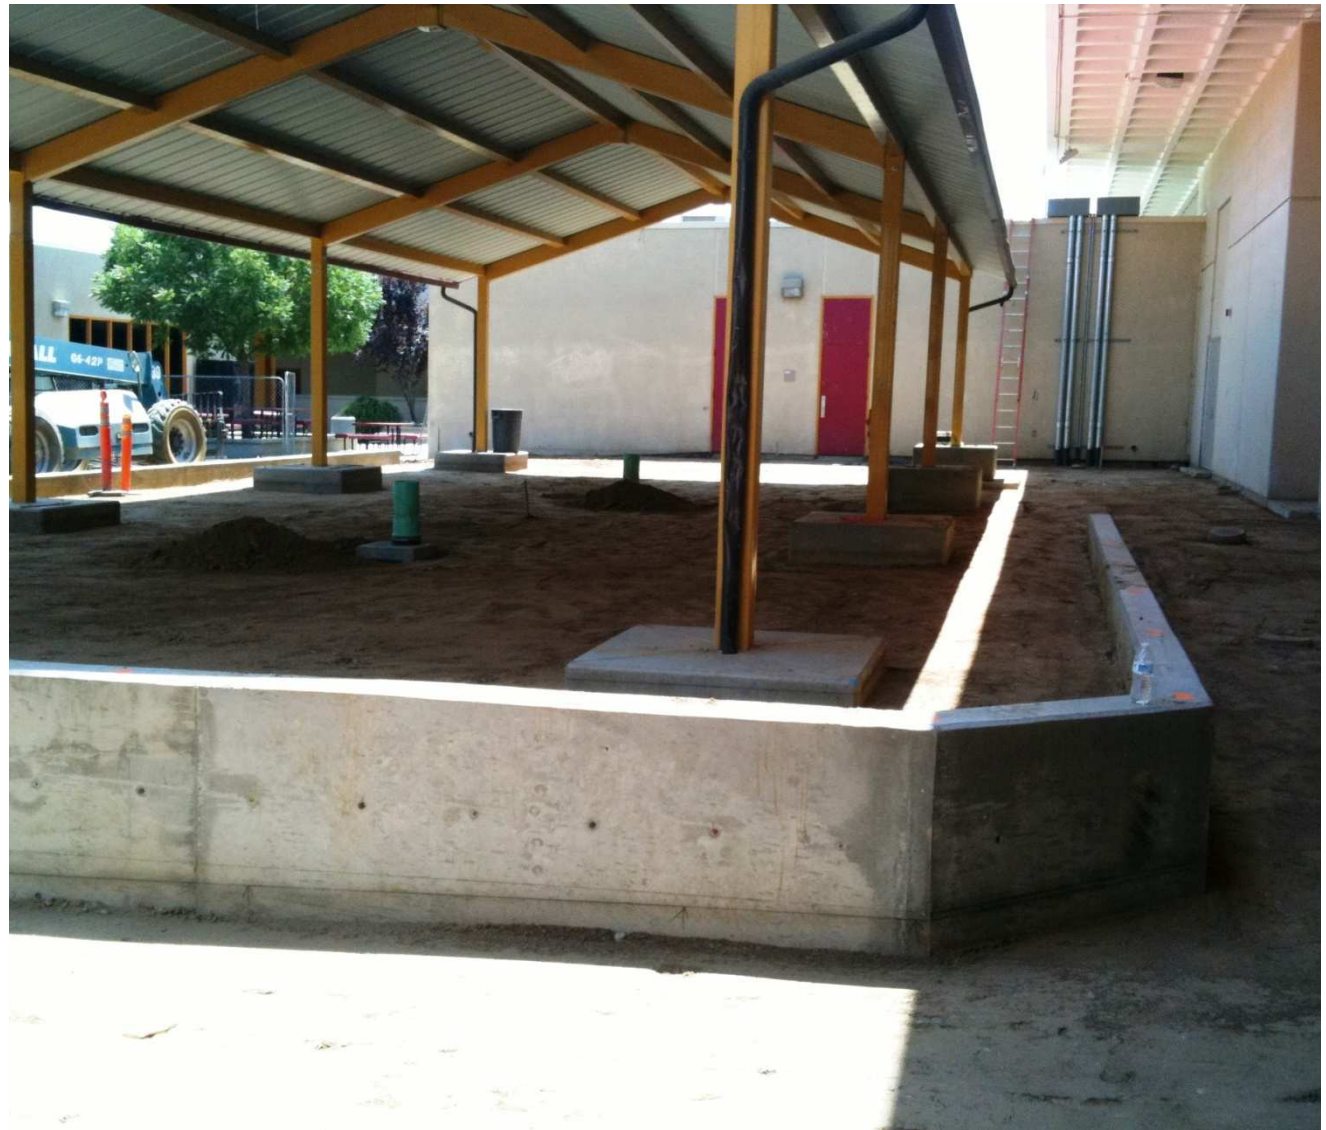
Summer Modernization

July 27th, 2011: Upon completion of the cast in place walls the grade around and under the lunch shelter has been established. Catch basins under the lunch shelter are in the process of being adjusted.

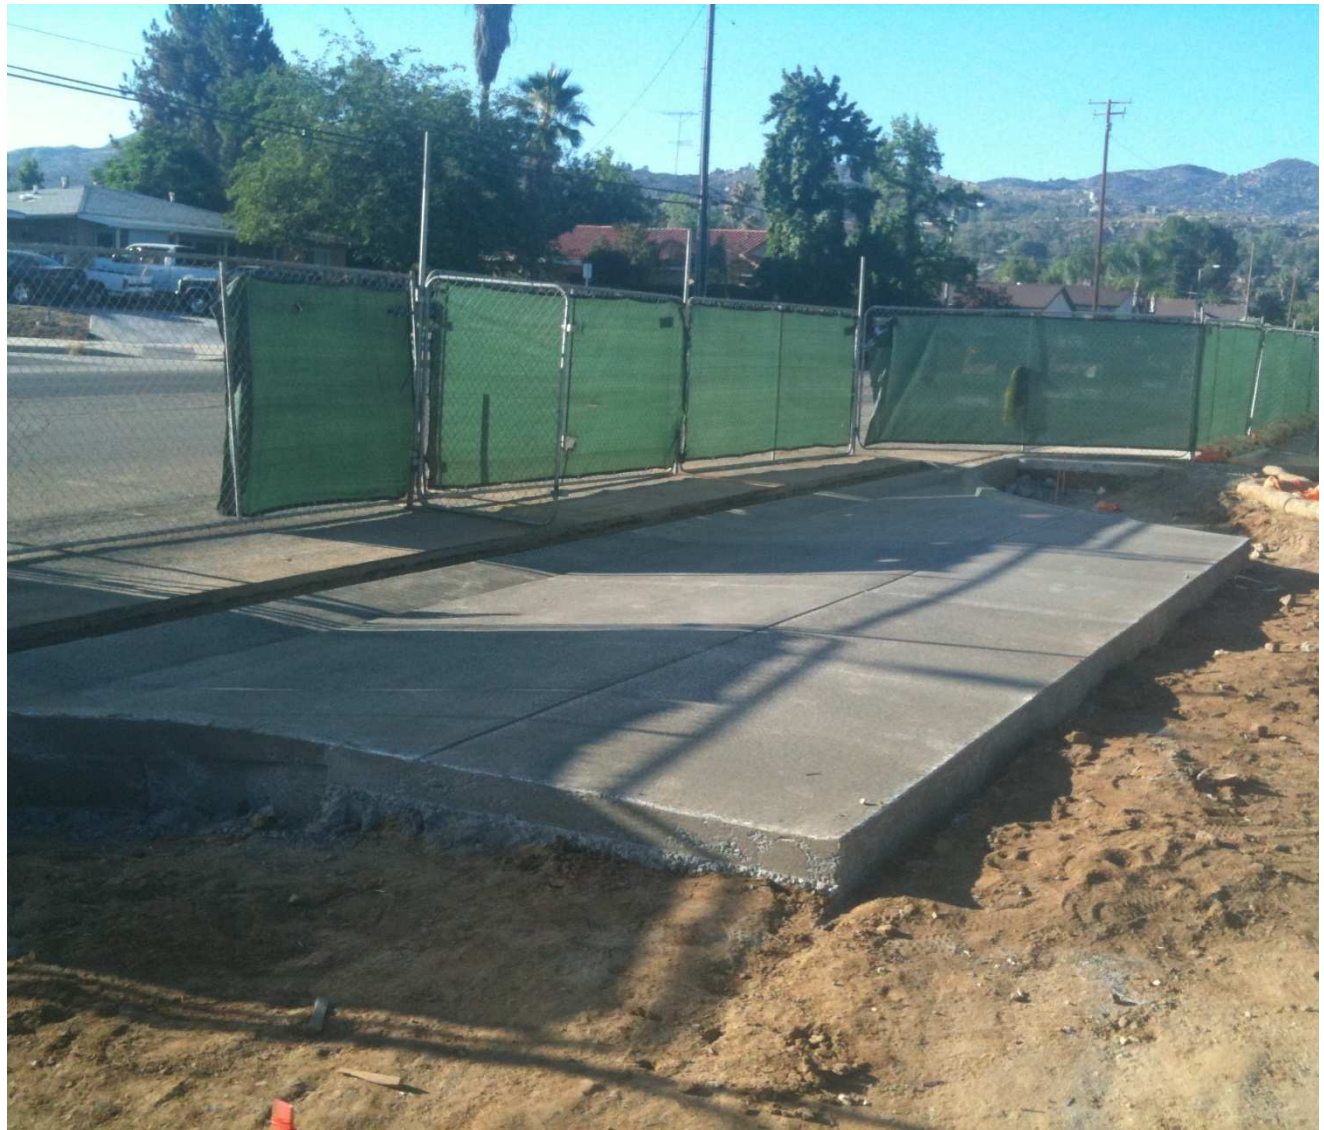
Street Improvements

July 21st, 2011: New driveway approaches have been constructed at the entry and exit of the new student drop off and fire lanes.
