Construction Progress Photo Report
August 18, 2011

Hemet High Modernization & Expansion

FACILITES & PLANNING DEPARTMENT

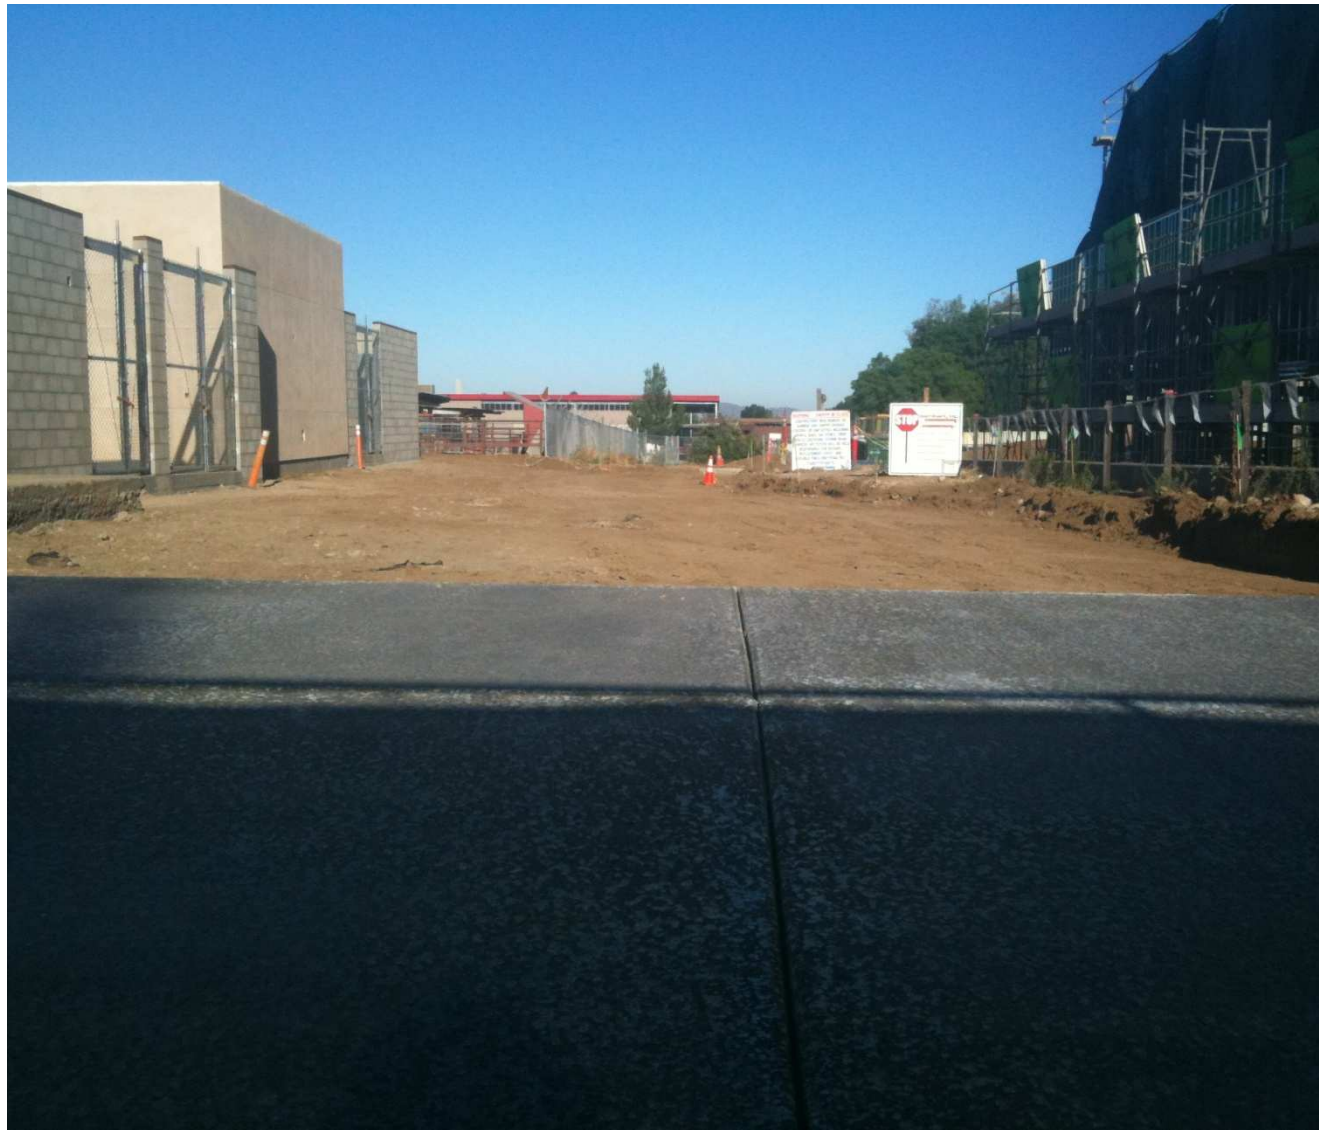
Fire Lane

July 21st, 2011: Rough grading has commenced at the fire lane. The new approach for the fire lane is shown in the foreground

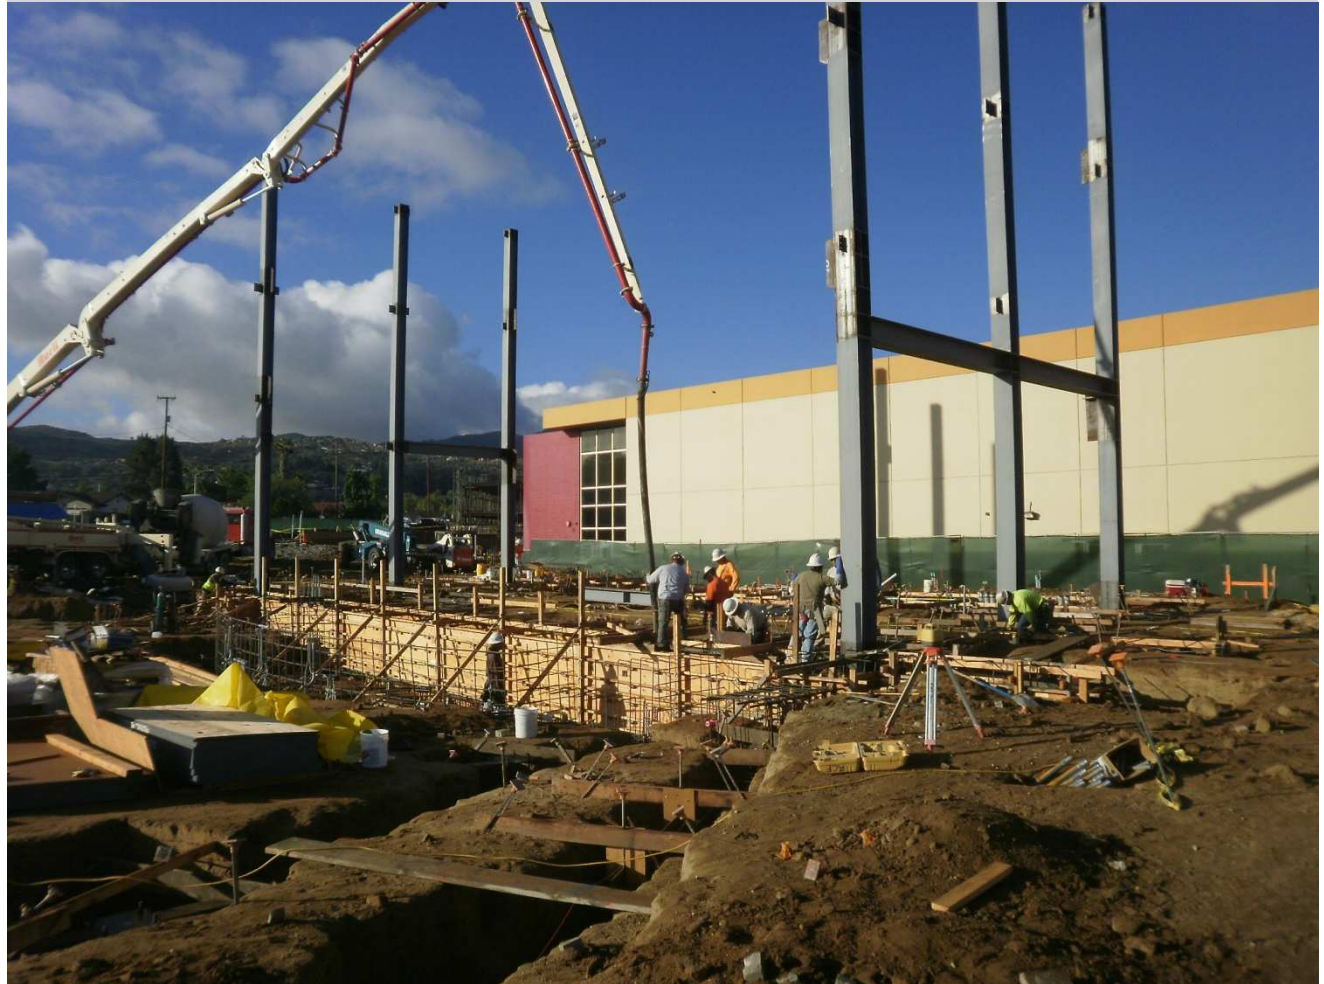
Theater Building "A"

June 9th, 2011: Stage wall being poured.

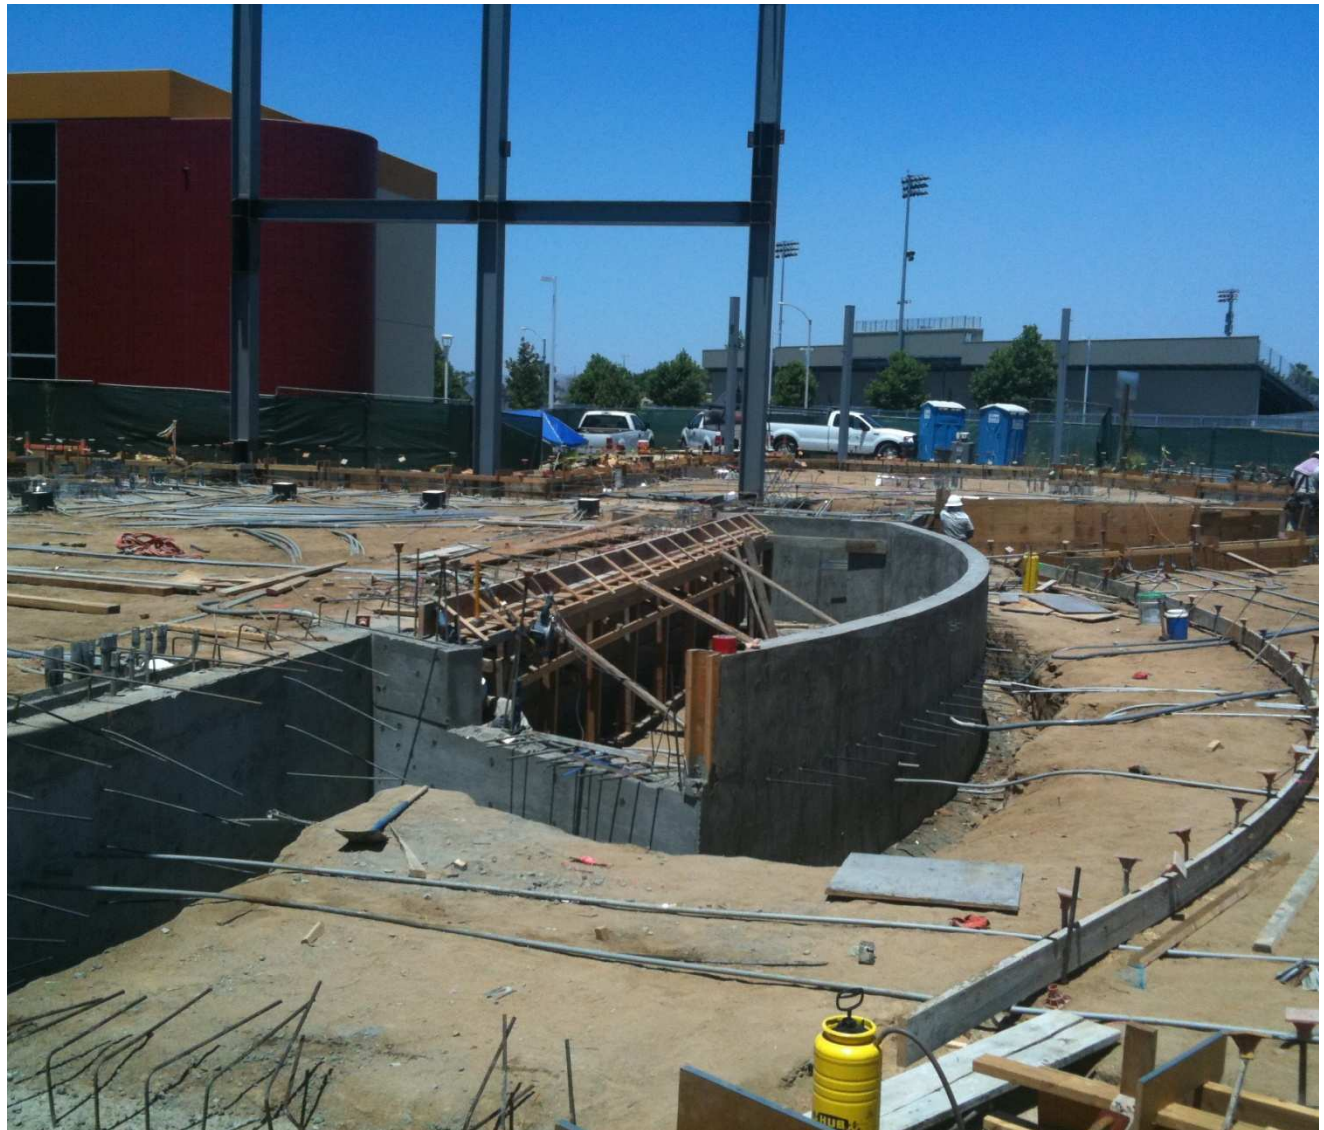
Theater Building "A"

June 29th, 2011: The orchestra pit wall has been poured in place.

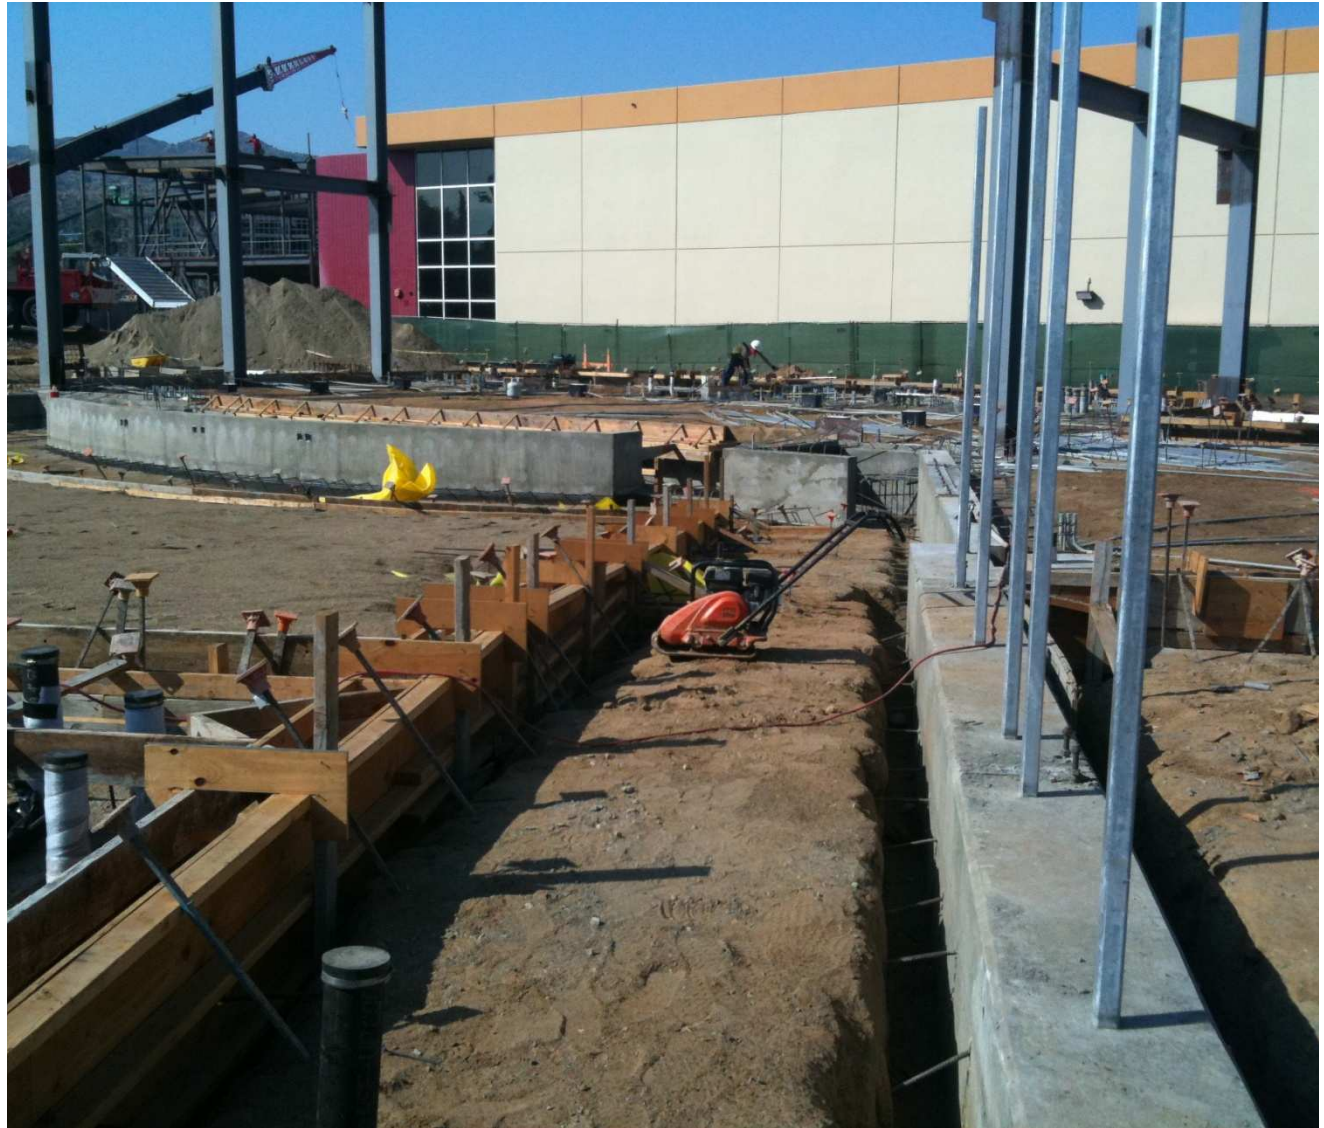
Theater Building "A"

July 7th, 2011: Curb forms are being constructed along one of the two ramps leading down to the stage.

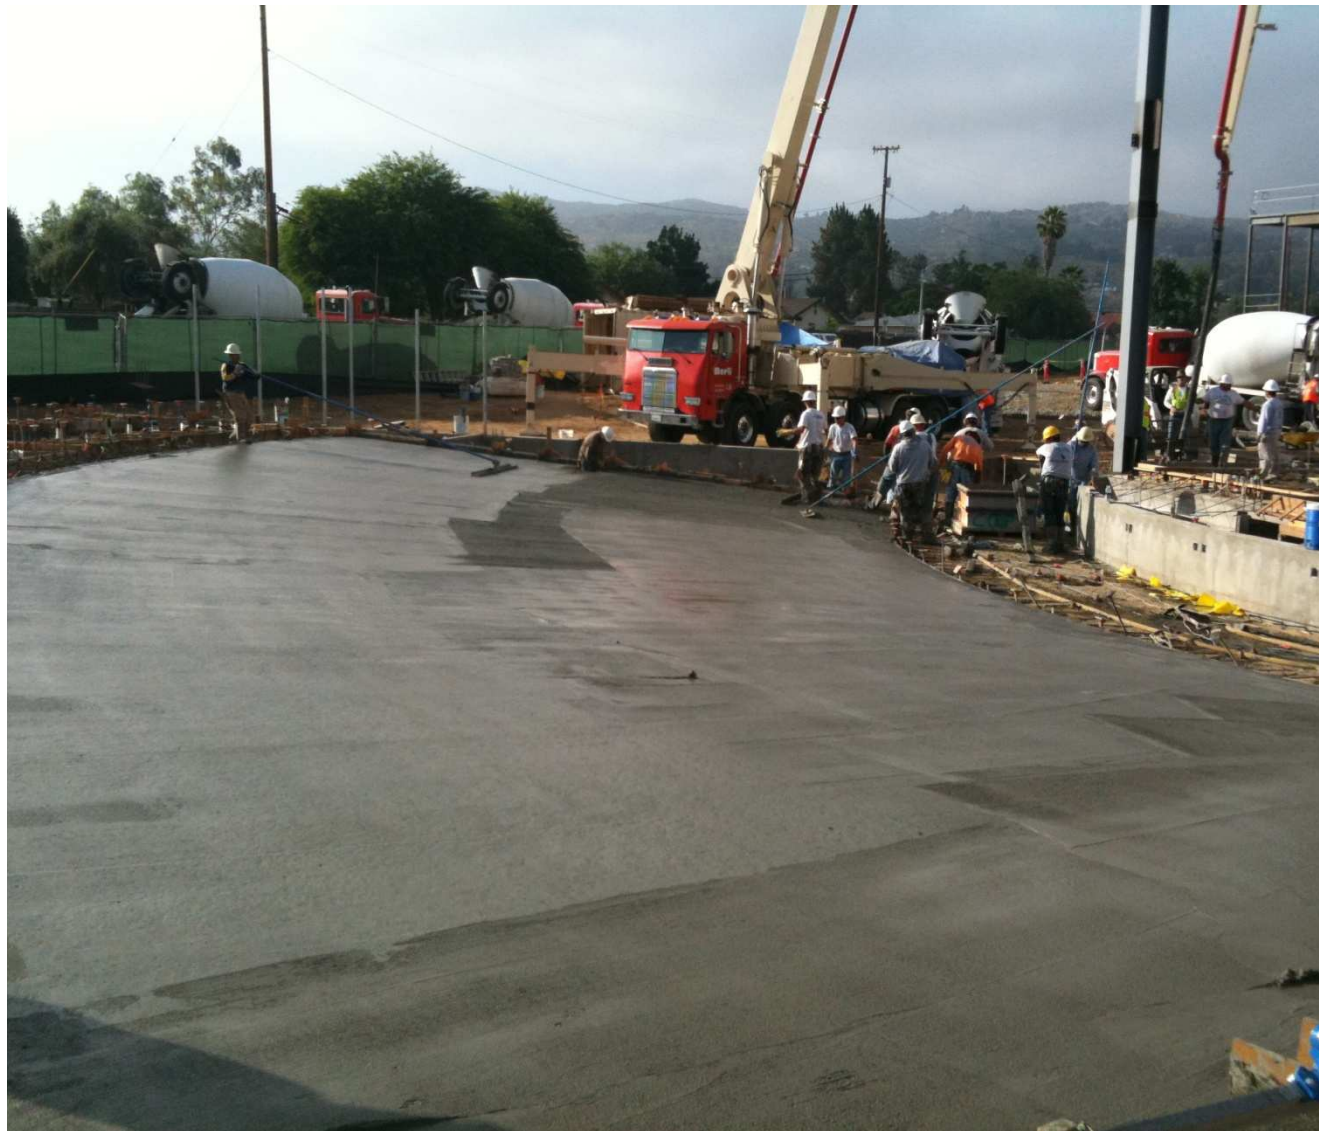
Theater Building "A"

July 14th: The seating area slab on grade has been poured and is being finished. In the background the crew is beginning the SOG pour at the stage.

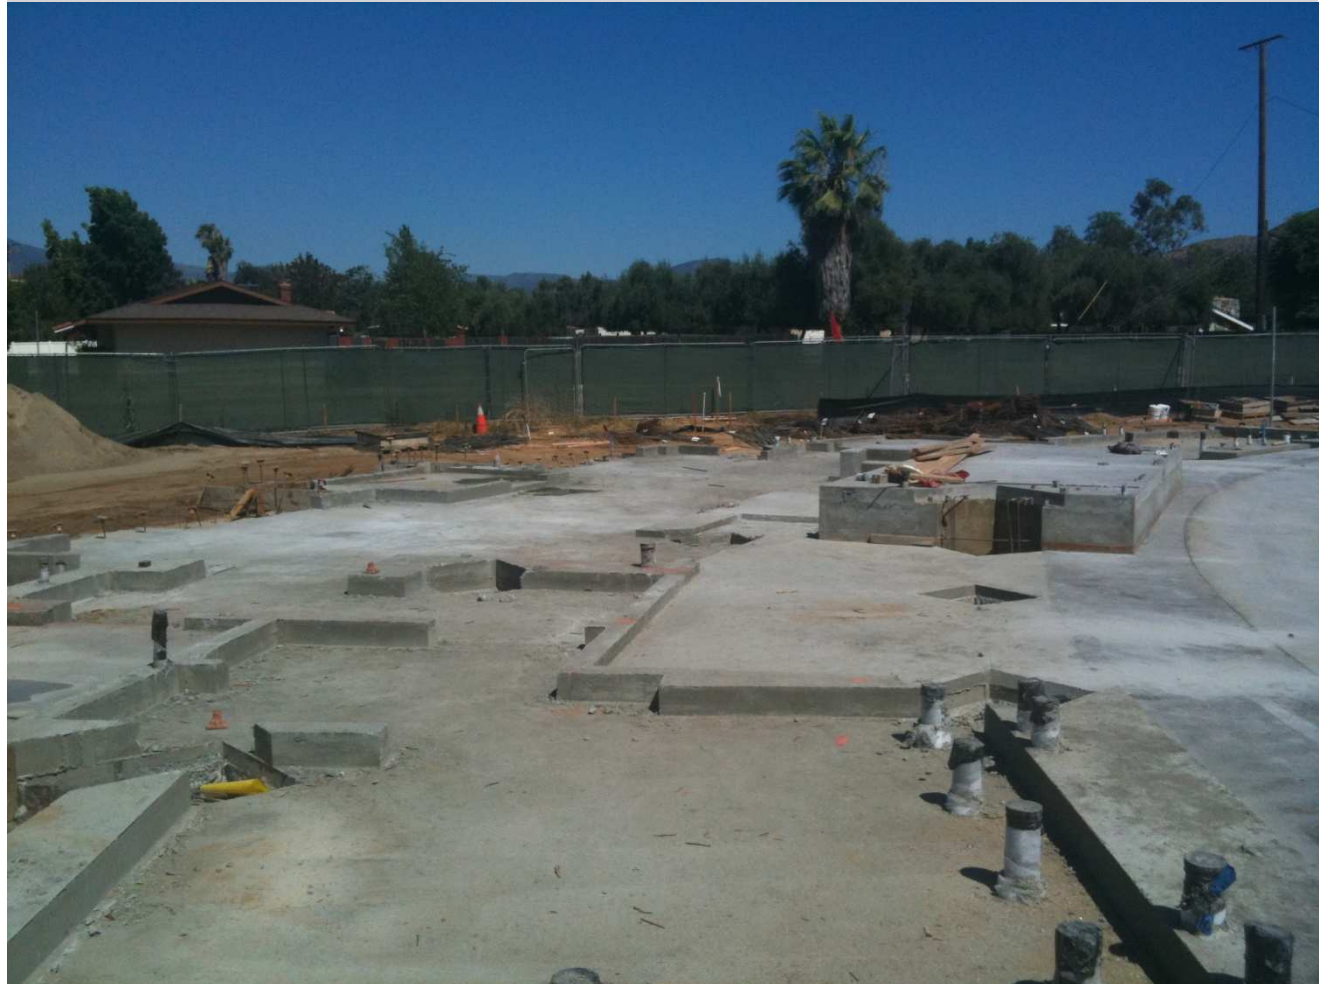
Theater Building "A"

July 21st, 2011: The bathrooms, lobby and flat areas of the seating area have been poured.

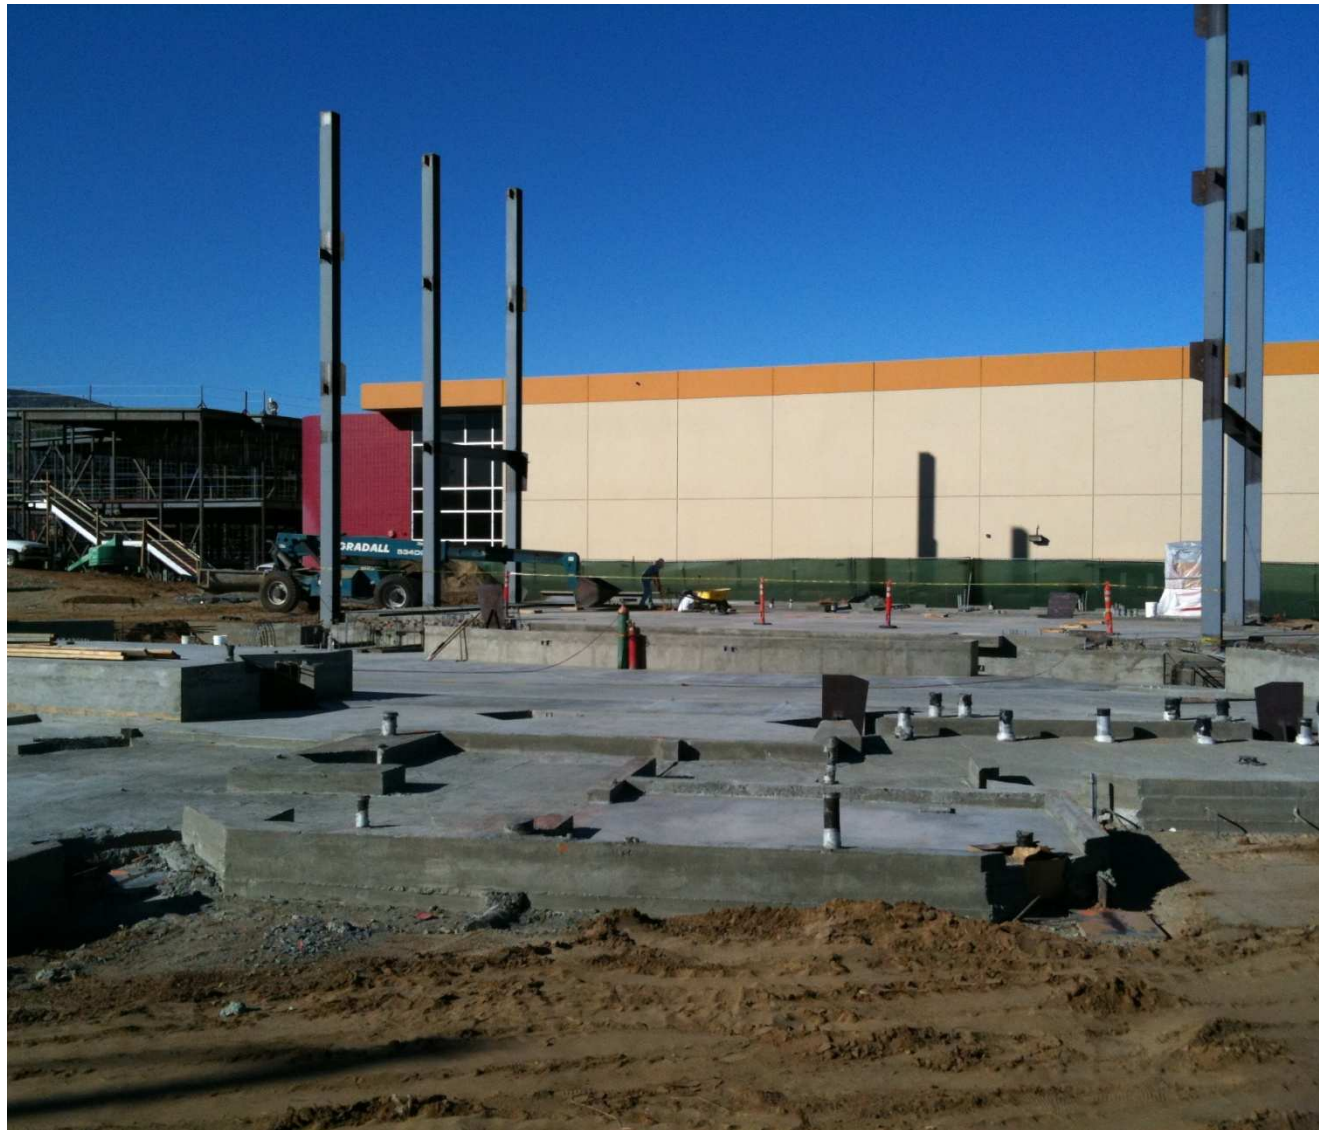
Theater Building "A"

July 21st, 2011: The structural steel knife plates are being installed where cross braced frames are required. The columns will be lowered into position over the knife plates and welded into place.

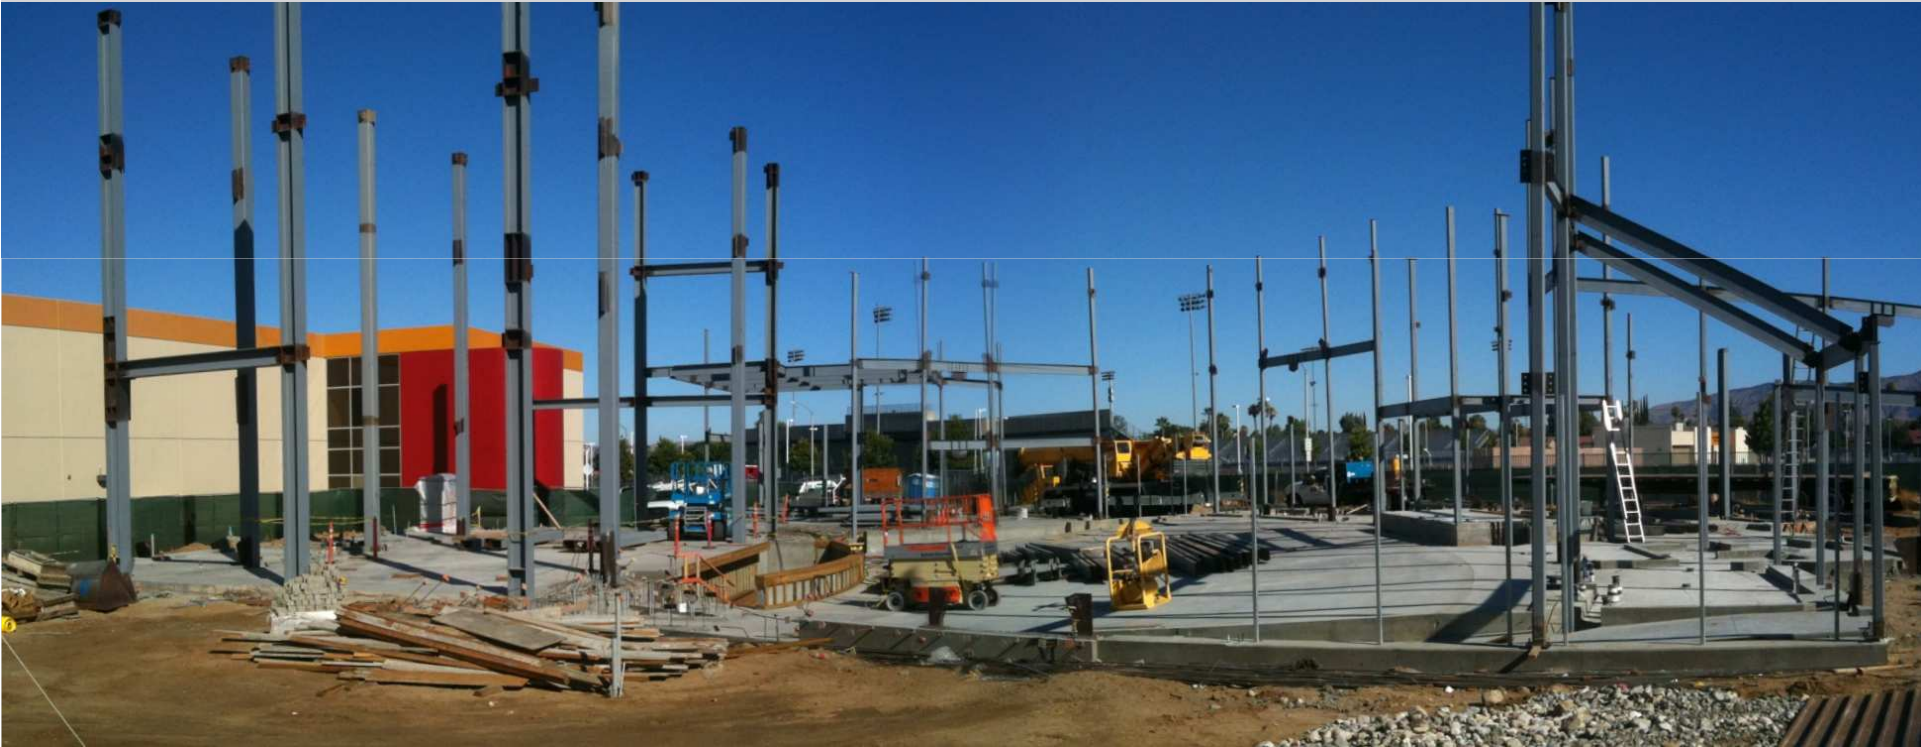
Building "A"-8/3/11: Theater building steel erection is in progress .

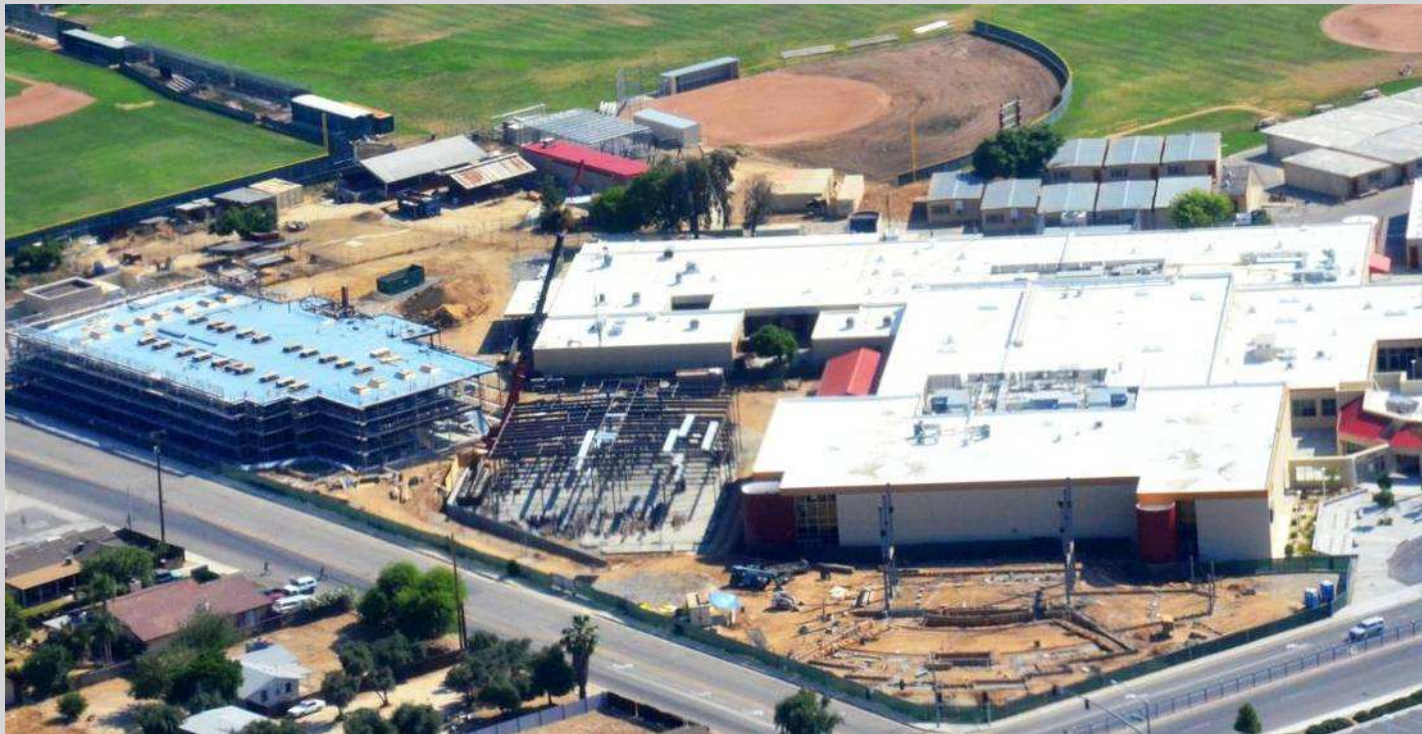
6/29/11: Aerial photo at the corner of Stetson and Stanford Ave. The theater building faces this intersection.
